# Access Compliance Report

## Public Rights-of-Way

### (Curb Ramps)

Intersection ID: 31905	Main Street: PALOMAR_MOUNTAIN_DR	Cross Street: STOWE_DERBY_DR	Location: SE
ADA ID: 18EBB1841D2F	Ramp Type: BlendTrans2	Initial Pass/Fail: Fail	Overall Compliance: No
Severity Score: 33.75			
Codes/Mitigation Info/Possible Solution		Field Measurements/Component Compliance

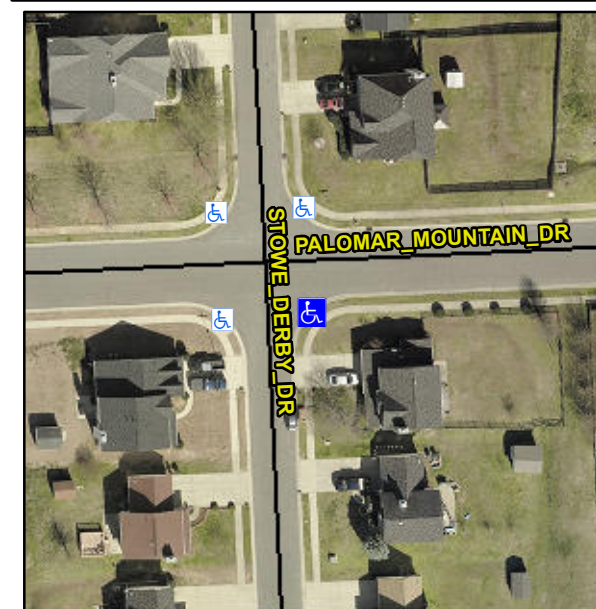
Compliance	Description	Data	Compliance	Description	Data
N/A	Ramp Length (in)	95.0	Yes	BlendTrans Slope (%)	2.5
No	Ramp Width (in)	39.5	No	BlendTrans XSlope (%)	7.0
N/A	Flare Type LT	N/A	N/A	Flare Type RT	N/A
N/A	Flare Slope LT (%)	N/A	N/A	Flare Slope RT (%)	N/A
N/A	Flare Traversable LT?	N/A	N/A	Flare Traversable RT?	N/A
N/A	Landing Length (in)	N/A	N/A	DWS Provided?	N/A
N/A	Landing Width (in)	N/A	N/A	DWS Contrast?	N/A
N/A	Landing Slope (%)	N/A	N/A	DWS Length (in)	N/A
N/A	Landing X Slope (%)	N/A	N/A	DWS Full Width?	N/A
N/A	Landing Curb? (Y/N)	N/A	N/A	DWS Offset (in)	N/A
N/A	Shared Landing?	N/A			
N/A	Gutter Ponding?	N/A	N/A	Gutter Slope (%)	N/A
N/A	Gutter Lip Ht (in)	N/A	N/A	Gutter X Slope (%)	N/A
N/A	Painted X Walk1?	No	N/A	Painted X Walk2?	No
	X Walk 1 Direction	To N		X Walk 2 Direction	To W
	X Walk 1 Width (in)	N/A		X Walk 2 Width (in)	N/A
	X Walk 1 Slope (%)	4.9		X Walk 2 Slope (%)	0.2
	X Walk 1 X Slope (%)	1.2		X Walk 2 X Slope (%)	6.6

N/A	Ramp inside XWalk1?	N/A	N/A	Ramp inside XWalk2?	N/A
	Road Slope (%)	5.2		Clear Space?	N/A
	Road X Slope (%)	1.8	N/A	Clear Space to XWalk (in)	N/A
N/A	Any Obstructions?	N/A	N/A	Storm Grate/Utility Hazard?	N/A
	Obstruction Type			Storm Grate/Utility Type	
		N/A			N/A
			Yes	Surface Condition? (G/P)	Good
			N/A	Curb Slope (%)	3.3

Possible Solutions:

**Remove & Replace Curb Ramp With Two New Directional Ramps or Equivalent.**

**R304.5.1, R304.5.3**

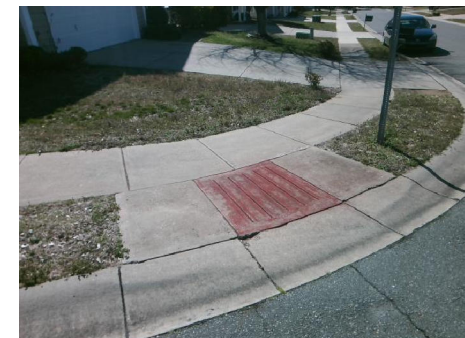
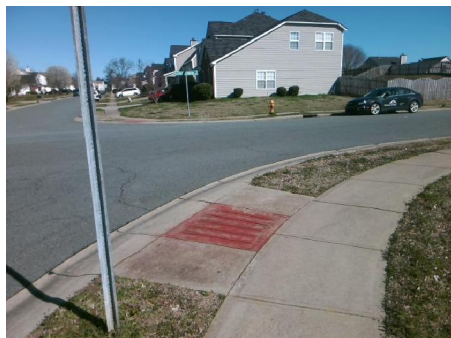
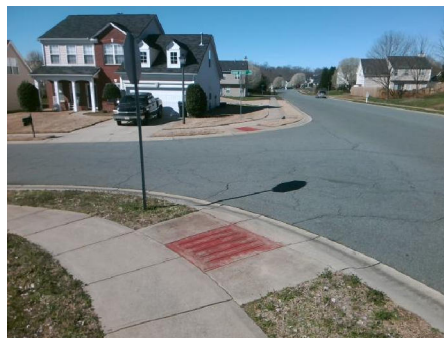
Street 1 Name PALOMAR MOUNTAIN DR

Stop Condition-Street 1 None

Street 2 Name STOWE DERBY DR

Stop Condition-Street 2 StopSign
