# Access Compliance Report

## Public Rights-of-Way

### (Curb Ramps)

| Intersection ID: 31486 | Main Street: CLOVER_GAP_DR | Cross Street: ELISE_MARIE_DR | Location: W |

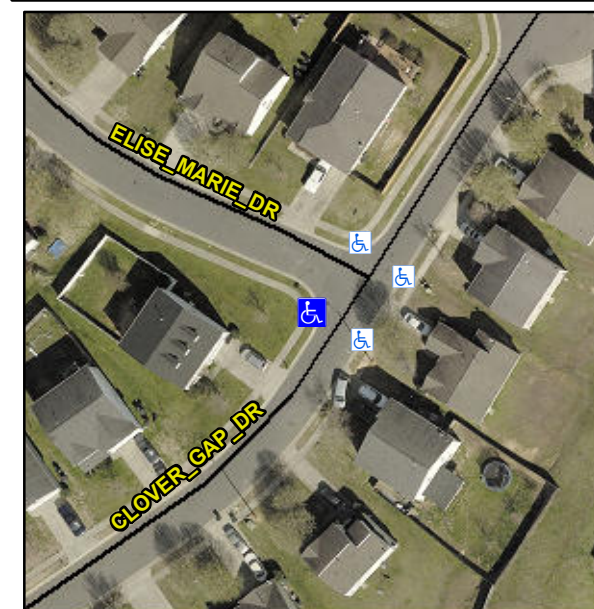
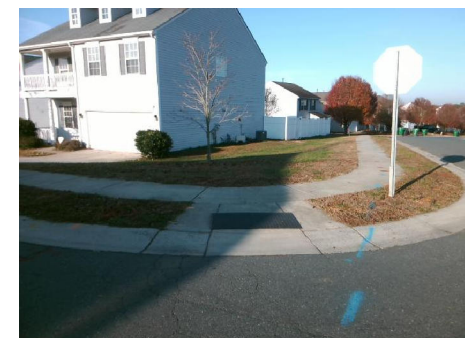
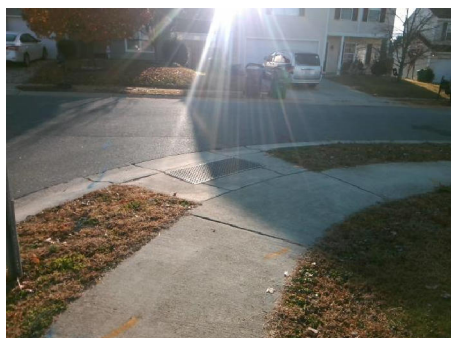
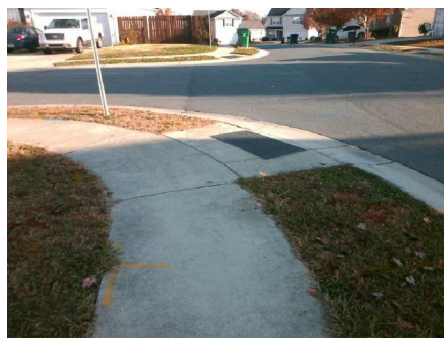
| ADA ID: 18F34D3BDB04 | Ramp Type: BlendTrans1 | Initial Pass/Fail: Fail | Overall Compliance: No |

**R304.5.1**

| Compliance | Description | Data | Compliance | Description | Data |
|---|---|---|---|---|---|
| No | Ramp Width (in) | 36.5 | Yes | BlendTrans XSlope (%) | 2.0 |

**Remove & Replace Curb Ramp With Two New Directional Ramps or Equivalent.**

**\$ 3200.00**
