Access Compliance Report

Public Rights-of-Way

(Curb Ramps)

Intersection ID: 46807	Main Street: ADLIN_AV	Cross Street: SWEET_BING_CT	Location:	N
ADA ID: 18FB08D94489	Ramp Type: PerpDiag	Initial Pass/Fail: Fail	Overall Compliance: No	Severity Score: 21.25
Codes/Mitigation Info/Possible Solution		Field Measurements/Component Compliance

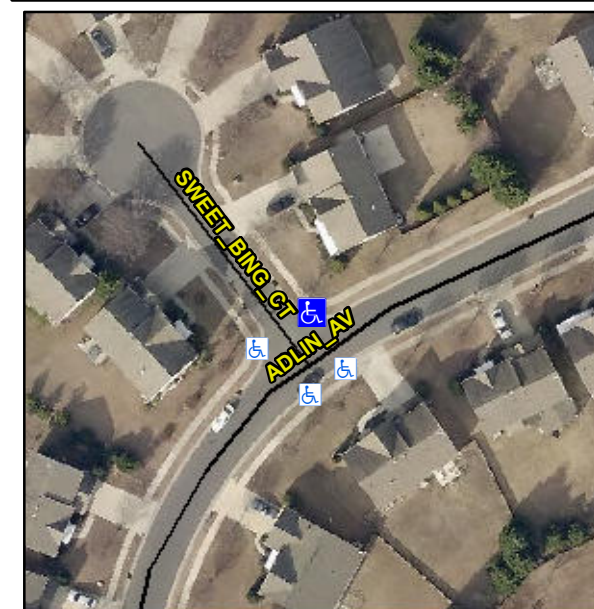
Not Found, R304.5.1, R304.2.2

Compliance	Description	Data	Compliance	Description	Data
N/A	Ramp Length (in)	48.5	No	Ramp Slope (%)	11.8
No	Ramp Width (in)	41.5	Yes	Ramp XSlope (%)	1.4
N/A	Flare Type LT	N/A	N/A	Flare Type RT	N/A
N/A	Flare Slope LT (%)	N/A	N/A	Flare Slope RT (%)	N/A
N/A	Flare Traversable LT?	N/A	N/A	Flare Traversable RT?	N/A
N/A	Landing Length (in)	N/A	N/A	DWS Provided?	N/A
N/A	Landing Width (in)	N/A	N/A	DWS Contrast?	N/A
N/A	Landing Slope (%)	N/A	N/A	DWS Length (in)	N/A
N/A	Landing X Slope (%)	N/A	N/A	DWS Full Width?	N/A
N/A	Landing Curb? (Y/N)	N/A	N/A	DWS Offset (in)	N/A
N/A	Shared Landing?	N/A			
N/A	Gutter Ponding?	N/A	N/A	Gutter Slope (%)	N/A
N/A	Gutter Lip Ht (in)	N/A	N/A	Gutter X Slope (%)	N/A
N/A	Painted X Walk1?	No	N/A	Painted X Walk2?	No
	X Walk 1 Direction	To SW		X Walk 2 Direction	To SE
N/A	X Walk 1 Width (in)	N/A	N/A	X Walk 2 Width (in)	N/A
	X Walk 1 Slope (%)	2.2		X Walk 2 Slope (%)	0.4
	X Walk 1 X Slope (%)	0.8		X Walk 2 X Slope (%)	1.7

N/A	Ramp inside XWalk1?	N/A	N/A	Ramp inside XWalk2?	N/A
	Road Slope (%)	2.3	N/A	Clear Space?	N/A
	Road X Slope (%)	1.3	N/A	Clear Space to XWalk (in)	N/A
N/A	Any Obstructions?	N/A	N/A	Storm Grate/Utility Hazard?	N/A
	Obstruction Type			Storm Grate/Utility Type	
		N/A			N/A
			Yes	Surface Condition? (G/P)	Good

Possible Solutions:

Remove & Replace Curb Ramp With Two New Directional Ramps or Equivalent.
