# Access Compliance Report

## Public Rights-of-Way (Curb Ramps)

Intersection ID: 48583	Main Street: STONEY_CREEK_LN	Cross Street: WATERLILY_LN	Location: NW
ADA ID: 1907A96528CE	Ramp Type: Perp	Initial Pass/Fail: Fail	Overall Compliance: No
		Severity Score: 8.75

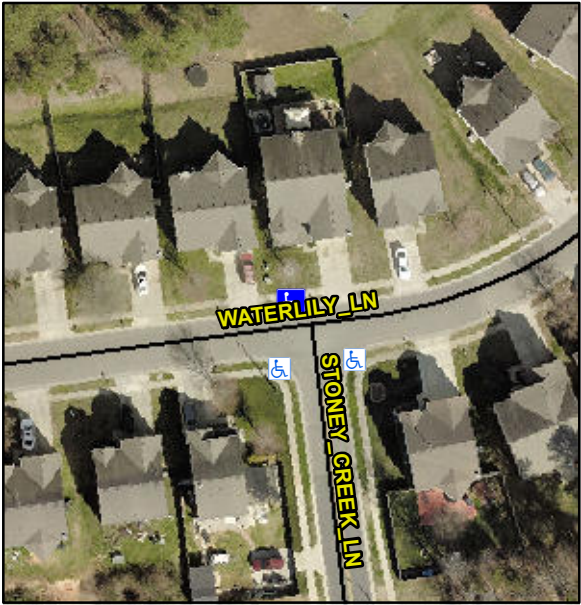
Possible Solutions:		<b>Compliance</b>	<b>Description</b>	<b>Data</b>
	<b>Remove &amp; Replace Entire Ramp.</b>		<b>Yes</b>	Ramp Length (in)	7.9
			<b>No</b>	Ramp Width (in)	0.2
			<b>N/A</b>	Flare Type LT	N/A
			<b>N/A</b>	Flare Slope LT (%)	N/A
			<b>N/A</b>	Flare Traversable LT?	N/A
			<b>N/A</b>	Landing Length (in)	N/A
			<b>N/A</b>	Landing Width (in)	N/A
			<b>N/A</b>	Landing Slope (%)	N/A
			<b>N/A</b>	Landing X Slope (%)	N/A
<p>Surveyor Notes:</p> <p><b>N/A</b></p> <p>PROW/ADA:</p> <p><b>Not Found, R304.5.1</b></p>			<b>N/A</b>	Flare Type RT	N/A
			<b>N/A</b>	Flare Slope RT (%)	N/A
			<b>N/A</b>	Flare Traversable RT?	N/A
			<b>N/A</b>	DWS Provided?	N/A
			<b>N/A</b>	DWS Contrast?	N/A
			<b>N/A</b>	DWS Length (in)	N/A
			<b>N/A</b>	DWS Full Width?	N/A
			<b>N/A</b>	DWS Offset (in)	N/A
			<b>N/A</b>	Gutter Ponding?	N/A

<b>N/A</b>	Gutter Lip Ht (in)	N/A
			<b>No</b>	Painted X Walk1?	N/A
				X Walk 1 Direction	N/A
			<b>N/A</b>	X Walk 1 Width (in)	N/A
			<b>3.4</b>	X Walk 1 Slope (%)	N/A
			<b>1.6</b>	X Walk 1 X Slope (%)	N/A
			<b>N/A</b>	Ramp inside XWalk1?	N/A
			<b>N/A</b>	Road Slope (%)	N/A
			<b>N/A</b>	Road X Slope (%)	N/A
			<b>N/A</b>	Any Obstructions?	N/A
				Obstruction Type	N/A
Total Cost:		\$ 1850.00	<b>N/A</b>	Storm Grate/Utility Hazard?	N/A
			<b>N/A</b>	Storm Grate/Utility Type	N/A
			<b>Yes</b>	Surface Condition? (G/P)	Good
