Access Compliance Report Public Rights-of-Way (Curb Ramps)

Intersection ID: 13960 Main Street: CENTRAL_AV Cross Street: KILBORNE_DR Location: NW Severity Score: 13.75 **ADA ID: 190ABB7A84AE** Ramp Type: Para Initial Pass/Fail: Fail **Overall Compliance: No**

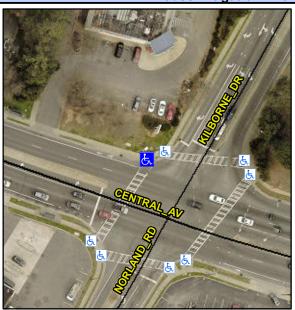
Data	iance Description	Comp	Data	liance Description	Comp
48.0	Ramp Length RT (in)	N/A	55.5	Ramp Length LT (in)	N/A
60.0	Ramp Width RT (in)	Yes	60.0	Ramp Width LT (in)	Yes

8.8	Ramp Slope RT (%)	No	4.2	Ramp Slope LT (%)	Yes
3.1	Ramp XSlope RT (%)	No	3.9	Ramp XSlope LT (%)	No
N/A	DWS Provided?	N/A	N/A	Landing Length (in)	N/A
N/A	DWS Contrast?	N/A	N/A	Landing Width (in)	N/A
N/A	DWS Length (in)	N/A	N/A	Landing Slope (%)	N/A
N/A	DWS Full Width?	N/A	N/A	Landing X Slope (%)	N/A
N/A	DWS Offset (in)	N/A	N/A	Landing Curb? (Y/N)	N/A
			N/A	Shared Landing?	N/A
N/A	Gutter Slope (%)	N/A	N/A	Gutter Ponding?	N/A
N/A	Gutter X Slope (%)	N/A	N/A	Gutter Lip Ht (in)	N/A
N/A	Painted X Walk2?	N/A	Yes	Painted X Walk1?	N/A
N/A	X Walk 2 Direction		To S	X Walk 1 Direction	
N/A	X Walk 2 Width (in)	N/A	101.0	X Walk 1 Width (in)	N/A
N/A	X Walk 2 Slope (%)		1.6	X Walk 1 Slope (%)	
N/A	X Walk 2 X Slope (%)		0.5	X Walk 1 X Slope (%)	
N/A	Ramp inside XWalk2?	N/A	Yes	Ramp inside XWalk1?	N/A
N/A	Clear Space?	N/A	N/A	Road Slope (%)	
N/A	Clear Space to XWalk (in)	N/A	N/A	Road X Slope (%)	
N/A	Storm Grate/Utility Hazard?	N/A	N/A	Any Obstructions?	N/A

Storm Grate/Utility Type			Obstruction Type	
N/A			N/A		
Good	Surface Condition? (G/P)	Yes			
9.0	Curb Slope (%)	N/A

Possible Solution	
Possible Solutions:	Co
Remove & Replace Entire Ramp.	N/
•	Ye
	Ye
	No
	N/
	N/
Surveyor Notes:	N/
LT RP < 5%	N/
	N/
	N/
	N/
PROW/ADA:	N/
R304.5.3, R304.3.2	N/
	N/
	N/
