# Access Compliance Report

## Public Rights-of-Way

| Intersection ID: 27478 | Main Street: BALLANTYNE_MEADOWS_DR | Cross Street: BLUE_CEDAR_LN | Location: NW |
| ADA ID: 190DDB77CE81 | Ramp Type: PerpDiag | Initial Pass/Fail: Fail | Overall Compliance: No |

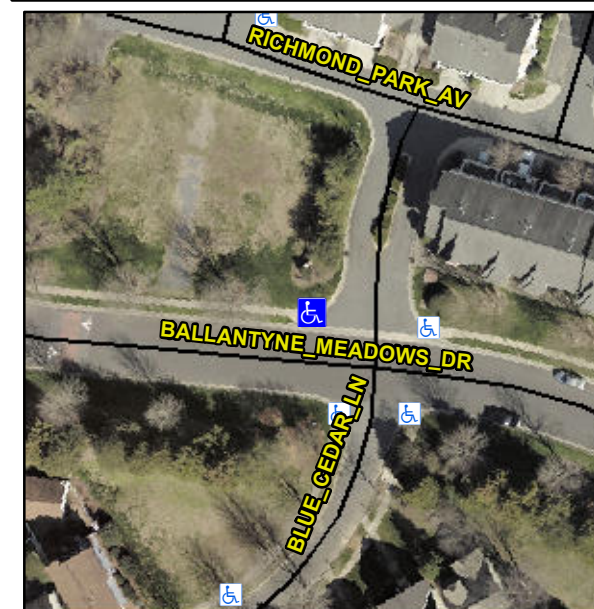
| Severity Score: 25 | | | |

**R304.2.2, R304.5.3**

| Compliance | Description | Data | Compliance | Description | Data |
|---|---|---|---|---|---|
| N/A | Ramp Length (in) | 51.0 | No | Ramp Slope (%) | 8.9 |
| Yes | Ramp Width (in) | 48.0 | No | Ramp XSlope (%) | 6.7 |

**Remove & Replace Curb Ramp With Two New Directional Ramps or Equivalent.**

Total Cost: \$ 3200.00
