Access Compliance Report

Public Rights-of-Way (Curb Ramps)

Intersection ID: 52918	Main Street: HOOVER_CREEK_BV	Cross Street: STEELE_CREEK_RD	Location: NW
ADA ID: 1912A5D24913	Ramp Type: Perp	Initial Pass/Fail: Fail	Overall Compliance: No
Severity Score: 12.5			
Codes/Mitigation Info/Possible Solution		Field Measurements/Component Compliance

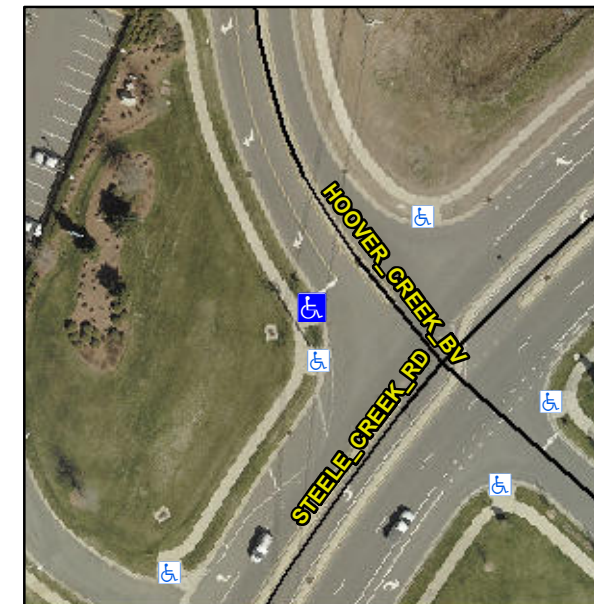
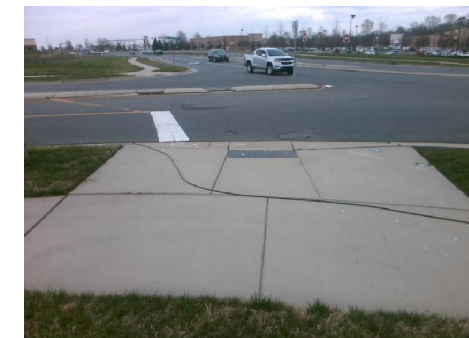
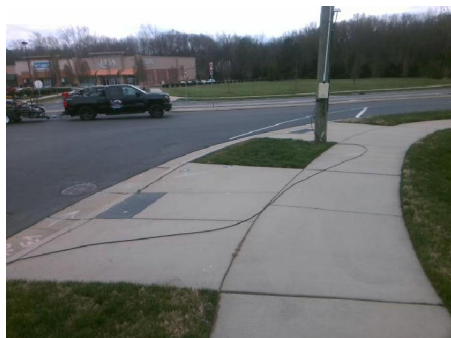
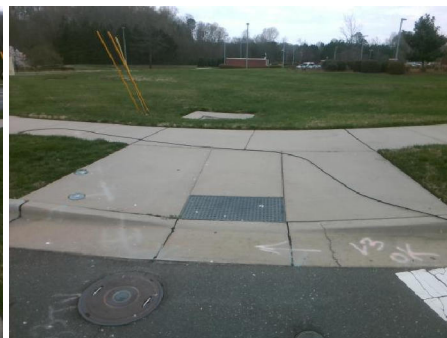
Not Found, R304.5.3

Compliance	Description	Data	Compliance	Description	Data
N/A	Ramp Length (in)	101.0	Yes	Ramp Slope (%)	7.9
Yes	Ramp Width (in)	48.0	No	Ramp XSlope (%)	6.9
N/A	Flare Type LT	N/A	N/A	Flare Type RT	N/A
N/A	Flare Slope LT (%)	N/A	N/A	Flare Slope RT (%)	N/A
N/A	Flare Traversable LT?	N/A	N/A	Flare Traversable RT?	N/A
N/A	Landing Length (in)	N/A	N/A	DWS Provided?	N/A
N/A	Landing Width (in)	N/A	N/A	DWS Contrast?	N/A
N/A	Landing Slope (%)	N/A	N/A	DWS Length (in)	N/A
N/A	Landing X Slope (%)	N/A	N/A	DWS Full Width?	N/A
N/A	Landing Curb? (Y/N)	N/A	N/A	DWS Offset (in)	N/A
N/A	Shared Landing?	N/A			
N/A	Gutter Ponding?	N/A	N/A	Gutter Slope (%)	N/A
N/A	Gutter Lip Ht (in)	N/A	N/A	Gutter X Slope (%)	N/A
N/A	Painted X Walk1?	No	N/A	Painted X Walk2?	N/A
	X Walk 1 Direction	To NE		X Walk 2 Direction	N/A
N/A	X Walk 1 Width (in)	N/A	N/A	X Walk 2 Width (in)	N/A
	X Walk 1 Slope (%)	2.3		X Walk 2 Slope (%)	N/A
	X Walk 1 X Slope (%)	2.9		X Walk 2 X Slope (%)	N/A

N/A	Ramp inside XWalk1?	N/A	N/A	Ramp inside XWalk2?	N/A
	Road Slope (%)	N/A	N/A	Clear Space?	N/A
	Road X Slope (%)	N/A	N/A	Clear Space to XWalk (in)	N/A
N/A	Any Obstructions?	N/A	N/A	Storm Grate/Utility Hazard?	N/A
	Obstruction Type			Storm Grate/Utility Type	
		N/A			N/A
		Yes		Surface Condition? (G/P)	Good

Possible Solutions:

Remove & Replace Entire Ramp.

Total Cost: \$ 1850.00
