Access Compliance Report

Public Rights-of-Way

(Curb Ramps)

Intersection ID: 19242	Main Street: SHARON_LN	Cross Street: SHARON_RD	Location: NE
ADA ID: 1915461C326C	Ramp Type: Para	Initial Pass/Fail: Fail	Overall Compliance: No
Severity Score: 26.25			
Codes/Mitigation Info/Possible Solution		Field Measurements/Component Compliance

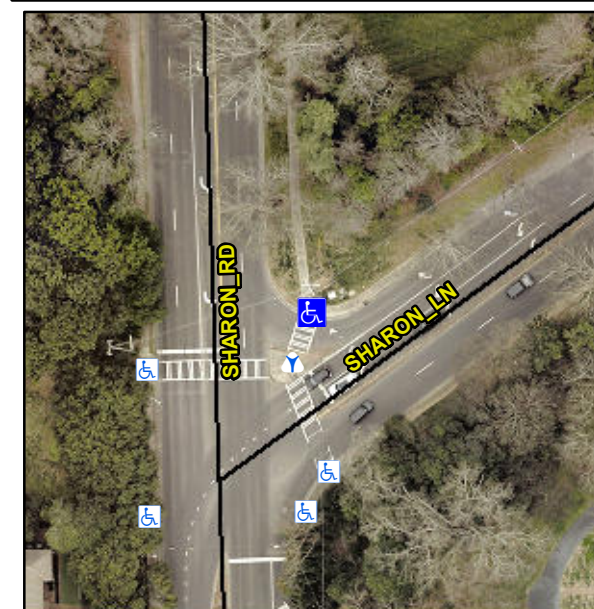
R304.5.1, R304.3.2, R304.5.3

Compliance	Description	Data	Compliance	Description	Data
N/A	Ramp Length LT (in)	N/A	N/A	Ramp Length RT (in)	67.0
N/A	Ramp Width LT (in)	N/A	No	Ramp Width RT (in)	45.0
N/A	Ramp Slope LT (%)	N/A	No	Ramp Slope RT (%)	13.7
N/A	Ramp XSlope LT (%)	N/A	No	Ramp XSlope RT (%)	3.1
N/A	Landing Length (in)	N/A	N/A	DWS Provided?	N/A
N/A	Landing Width (in)	N/A	N/A	DWS Contrast?	N/A
N/A	Landing Slope (%)	N/A	N/A	DWS Length (in)	N/A
N/A	Landing X Slope (%)	N/A	N/A	DWS Full Width?	N/A
N/A	Landing Curb? (Y/N)	N/A	N/A	DWS Offset (in)	N/A
N/A	Shared Landing?	N/A			
N/A	Gutter Ponding?	N/A	N/A	Gutter Slope (%)	N/A
N/A	Gutter Lip Ht (in)	N/A	N/A	Gutter X Slope (%)	N/A
N/A	Painted X Walk1?	Yes	N/A	Painted X Walk2?	N/A
	X Walk 1 Direction	To SW		X Walk 2 Direction	N/A
N/A	X Walk 1 Width (in)	109.0	N/A	X Walk 2 Width (in)	N/A
	X Walk 1 Slope (%)	1.4		X Walk 2 Slope (%)	N/A
	X Walk 1 X Slope (%)	3.7		X Walk 2 X Slope (%)	N/A
N/A	Ramp inside XWalk1?	Yes	N/A	Ramp inside XWalk2?	N/A

Road Slope (%)	N/A	N/A	Clear Space?	N/A
	Road X Slope (%)	N/A	N/A	Clear Space to XWalk (in)	N/A
N/A	Any Obstructions?	N/A	N/A	Storm Grate/Utility Hazard?	N/A
	Obstruction Type			Storm Grate/Utility Type	
		N/A			N/A
			Yes	Surface Condition? (G/P)	Good
			N/A	Curb Slope (%)	17.9

Possible Solutions:

Remove & Replace Entire Ramp.
