# Access Compliance Report

## Public Rights-of-Way

### (Curb Ramps)

Intersection ID: 8735	Main Street: GLENWOOD_DR	Cross Street: N/A	Location: NE
ADA ID: 191726F08CDE	Ramp Type: Para	Initial Pass/Fail: Fail	Overall Compliance: No
Codes/Mitigation Info/Possible Solution		Field Measurements/Component Compliance	
Severity Score: 13.75

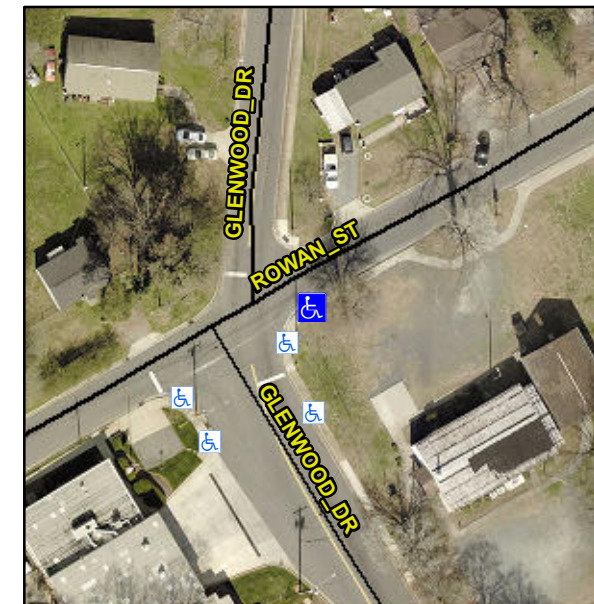
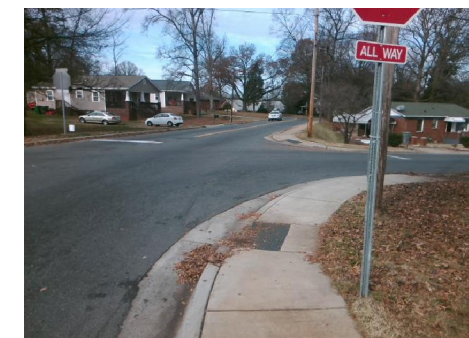
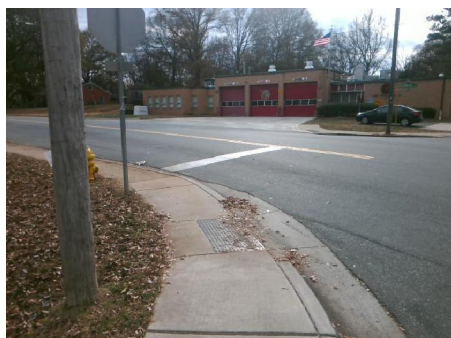
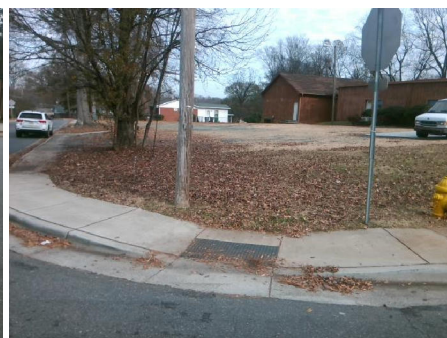
**LT RP < 5%**

**R304.3.2, R304.5.3**

Compliance	Description	Data	Compliance	Description	Data
N/A	Ramp Length LT (in)	59.5	N/A	Ramp Length RT (in)	60.0
Yes	Ramp Width LT (in)	50.0	Yes	Ramp Width RT (in)	50.0
Yes	Ramp Slope LT (%)	4.5	No	Ramp Slope RT (%)	11.5
Yes	Ramp XSlope LT (%)	2.0	No	Ramp XSlope RT (%)	2.1
N/A	Landing Length (in)	N/A	N/A	DWS Provided?	N/A
N/A	Landing Width (in)	N/A	N/A	DWS Contrast?	N/A
N/A	Landing Slope (%)	N/A	N/A	DWS Length (in)	N/A
N/A	Landing X Slope (%)	N/A	N/A	DWS Full Width?	N/A
N/A	Landing Curb? (Y/N)	N/A	N/A	DWS Offset (in)	N/A
N/A	Shared Landing?	N/A			
N/A	Gutter Ponding?	N/A	N/A	Gutter Slope (%)	N/A
N/A	Gutter Lip Ht (in)	N/A	N/A	Gutter X Slope (%)	N/A
N/A	Painted X Walk1?	No	N/A	Painted X Walk2?	N/A
	X Walk 1 Direction	To SW		X Walk 2 Direction	N/A
N/A	X Walk 1 Width (in)	N/A	N/A	X Walk 2 Width (in)	N/A
	X Walk 1 Slope (%)	6.2		X Walk 2 Slope (%)	N/A
	X Walk 1 X Slope (%)	1.9		X Walk 2 X Slope (%)	N/A
N/A	Ramp inside XWalk1?	N/A	N/A	Ramp inside XWalk2?	N/A

**Remove & Replace Entire Ramp.**
