# Access Compliance Report

## Public Rights-of-Way

### (Curb Ramps)

Intersection ID: 14035	Main Street: HANOVER_ST	Cross Street: SHENANDOAH_AV	Location:	N
ADA ID: 191767378A26	Ramp Type: Perp	Initial Pass/Fail: Fail	Overall Compliance: No	Severity Score: 33.75
Codes/Mitigation Info/Possible Solution		Field Measurements/Component Compliance

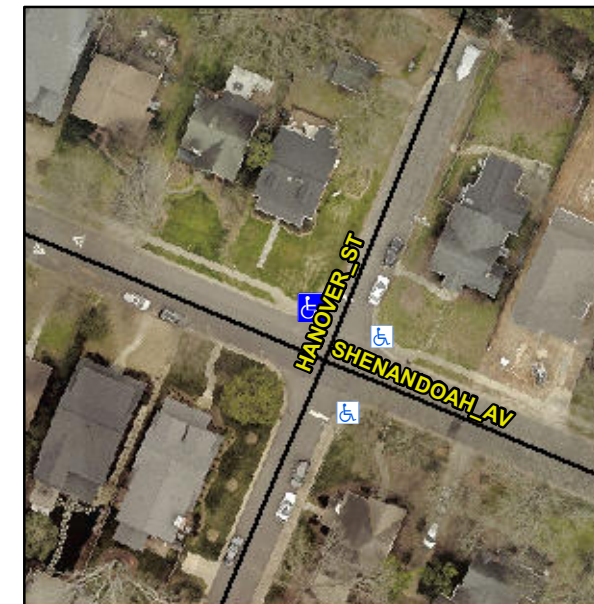
**Not Found, R304.5.1, R304.2.2, R304.5.3**

Compliance	Description	Data	Compliance	Description	Data
N/A	Ramp Length (in)	61.0	No	Ramp Slope (%)	8.5
No	Ramp Width (in)	40.0	No	Ramp XSlope (%)	5.9
N/A	Flare Type LT	N/A	N/A	Flare Type RT	N/A
N/A	Flare Slope LT (%)	N/A	N/A	Flare Slope RT (%)	N/A
N/A	Flare Traversable LT?	N/A	N/A	Flare Traversable RT?	N/A
N/A	Landing Length (in)	N/A	N/A	DWS Provided?	N/A
N/A	Landing Width (in)	N/A	N/A	DWS Contrast?	N/A
N/A	Landing Slope (%)	N/A	N/A	DWS Length (in)	N/A
N/A	Landing X Slope (%)	N/A	N/A	DWS Full Width?	N/A
N/A	Landing Curb? (Y/N)	N/A	N/A	DWS Offset (in)	N/A
N/A	Shared Landing?	N/A			
N/A	Gutter Ponding?	N/A	N/A	Gutter Slope (%)	N/A
N/A	Gutter Lip Ht (in)	0.5	N/A	Gutter X Slope (%)	N/A
N/A	Painted X Walk1?	No	N/A	Painted X Walk2?	N/A
	X Walk 1 Direction	To SE		X Walk 2 Direction	N/A
N/A	X Walk 1 Width (in)	N/A	N/A	X Walk 2 Width (in)	N/A
	X Walk 1 Slope (%)	0.7		X Walk 2 Slope (%)	N/A
	X Walk 1 X Slope (%)	5.5		X Walk 2 X Slope (%)	N/A

N/A	Ramp inside XWalk1?	N/A	N/A	Ramp inside XWalk2?	N/A
	Road Slope (%)	N/A	N/A	Clear Space?	N/A
	Road X Slope (%)	N/A	N/A	Clear Space to XWalk (in)	N/A
N/A	Any Obstructions?	N/A	N/A	Storm Grate/Utility Hazard?	N/A
	Obstruction Type			Storm Grate/Utility Type	
		N/A			N/A
			Yes	Surface Condition? (G/P)	Good

**Remove & Replace Entire Ramp.**

Total Cost: \$ 1850.00
