# Access Compliance Report

## Public Rights-of-Way

### (Curb Ramps)

Intersection ID: 14998	Main Street: DUNN_AV	Cross Street: GENE_AV	Location: SW
ADA ID: 193CCE4AF159	Ramp Type: PerpDiag	Initial Pass/Fail: Fail	Overall Compliance: No
Codes/Mitigation Info/Possible Solution		Field Measurements/Component Compliance	
Severity Score: 21.25

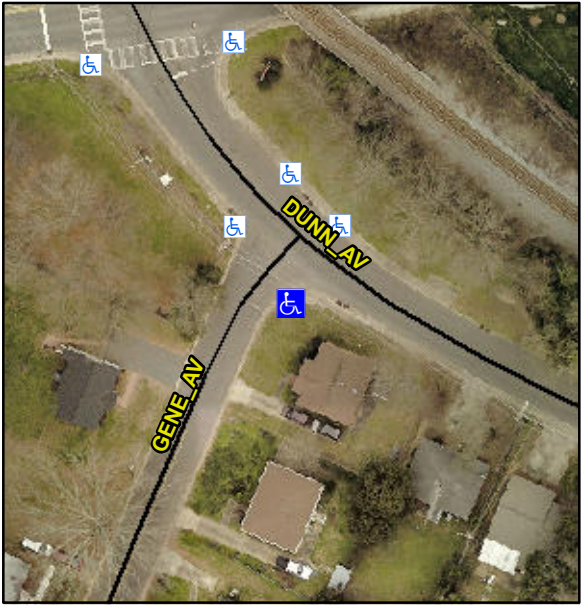
Possible Solutions:						
	Remove & Replace Curb Ramp With Two New Directional Ramps or Equivalent.	Compliance	Description	Data	Compliance	Description	Data
		N/A	Ramp Length (in)	55.0	No	Ramp Slope (%)	8.7
		No	Ramp Width (in)	40.0	Yes	Ramp XSlope (%)	0.2
		N/A	Flare Type LT	N/A	N/A	Flare Type RT	N/A
		N/A	Flare Slope LT (%)	N/A	N/A	Flare Slope RT (%)	N/A
		N/A	Flare Traversable LT?	N/A	N/A	Flare Traversable RT?	N/A
		N/A	Landing Length (in)	N/A	N/A	DWS Provided?	N/A
		N/A	Landing Width (in)	N/A	N/A	DWS Contrast?	N/A
		N/A	Landing Slope (%)	N/A	N/A	DWS Length (in)	N/A
<p>Surveyor Notes:</p> <p>N/A</p> <p>PROW/ADA:</p> <p>Not Found, R304.5.1, R304.2.2</p>		N/A	Landing X Slope (%)	N/A	N/A	DWS Full Width?	N/A
		N/A	Landing Curb? (Y/N)	N/A	N/A	DWS Offset (in)	N/A
		N/A	Shared Landing?	N/A			
		N/A	Gutter Ponding?	N/A	N/A	Gutter Slope (%)	N/A
		N/A	Gutter Lip Ht (in)	N/A	N/A	Gutter X Slope (%)	N/A
		N/A	Painted X Walk1?	No	N/A	Painted X Walk2?	No

X Walk 1 Direction	To NE		X Walk 2 Direction	To NW
		N/A	X Walk 1 Width (in)	N/A	N/A	X Walk 2 Width (in)	N/A
			X Walk 1 Slope (%)	2.6		X Walk 2 Slope (%)	3.8
			X Walk 1 X Slope (%)	2.7		X Walk 2 X Slope (%)	2.5
<p>Street 1 Name</p> <p>Stop Condition-Street 2</p> <p>Street 2 Name</p> <p>Stop Condition-Street 1</p>		N/A	Ramp inside XWalk1?	N/A	N/A	Ramp inside XWalk2?	N/A
			Road Slope (%)	0.6	N/A	Clear Space?	N/A
			Road X Slope (%)	0.8	N/A	Clear Space to XWalk (in)	N/A
		N/A	Any Obstructions?	N/A	N/A	Storm Grate/Utility Hazard?	N/A
			Obstruction Type			Storm Grate/Utility Type	
					N/A		N/A
					Yes	Surface Condition? (G/P)	Good
Total Cost:		\$	3200.00
