Access Compliance Report

Public Rights-of-Way

(Curb Ramps)

Intersection ID: N/A	Main Street: PINEVILLE-MATTHEWS_RD	Cross Street: PARK_RD	Location: SW
ADA ID: 193CD44A364B	Ramp Type: PerpDiag	Initial Pass/Fail: Fail	Overall Compliance: No
Codes/Mitigation Info/Possible Solution		Field Measurements/Component Compliance	
Severity Score: 33.75

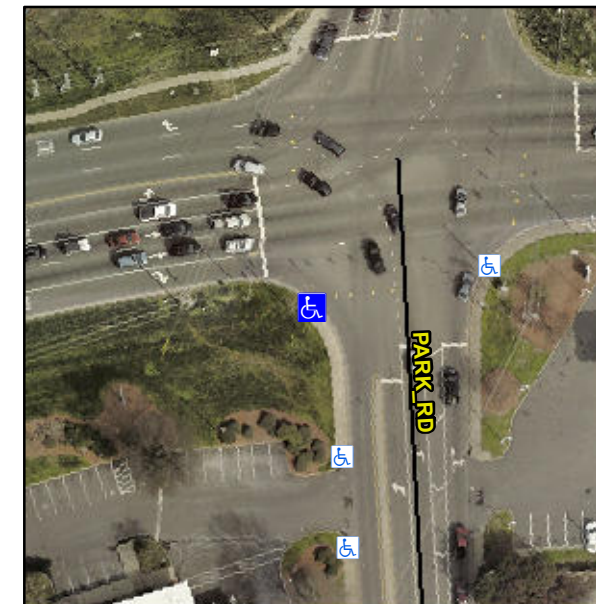
Compliance	Description	Data	Compliance	Description	Data
N/A	Ramp Length (in)	71.0	No	Ramp Slope (%)	9.9
No	Ramp Width (in)	46.0	No	Ramp XSlope (%)	5.7
N/A	Flare Type LT	N/A	N/A	Flare Type RT	N/A
N/A	Flare Slope LT (%)	N/A	N/A	Flare Slope RT (%)	N/A
N/A	Flare Traversable LT?	N/A	N/A	Flare Traversable RT?	N/A
N/A	Landing Length (in)	N/A	N/A	DWS Provided?	N/A
N/A	Landing Width (in)	N/A	N/A	DWS Contrast?	N/A
N/A	Landing Slope (%)	N/A	N/A	DWS Length (in)	N/A
N/A	Landing X Slope (%)	N/A	N/A	DWS Full Width?	N/A
N/A	Landing Curb? (Y/N)	N/A	N/A	DWS Offset (in)	N/A
N/A	Shared Landing?	N/A			
N/A	Gutter Ponding?	N/A	N/A	Gutter Slope (%)	N/A
N/A	Gutter Lip Ht (in)	N/A	N/A	Gutter X Slope (%)	N/A
N/A	Painted X Walk1?	No	N/A	Painted X Walk2?	No
	X Walk 1 Direction	To E		X Walk 2 Direction	To N
N/A	X Walk 1 Width (in)	N/A	N/A	X Walk 2 Width (in)	N/A
	X Walk 1 Slope (%)	2.8		X Walk 2 Slope (%)	4.8
	X Walk 1 X Slope (%)	4.7		X Walk 2 X Slope (%)	0.2

N/A	Ramp inside XWalk1?	N/A	N/A	Ramp inside XWalk2?	N/A
	Road Slope (%)	4.4	N/A	Clear Space?	N/A
	Road X Slope (%)	3.9	N/A	Clear Space to XWalk (in)	N/A
N/A	Any Obstructions?	N/A	N/A	Storm Grate/Utility Hazard?	N/A
	Obstruction Type			Storm Grate/Utility Type	
		N/A			N/A
			Yes	Surface Condition? (G/P)	Good

Remove & Replace Curb Ramp With Two New Directional Ramps or Equivalent.

R304.5.1, R304.2.2, R304.5.3
