Access Compliance Report

Public Rights-of-Way

(Curb Ramps)

Intersection ID: 32194	Main Street: BLAKEWOOD_DR	Cross Street: CHELTON_RIDGE_LN	Location: SW
ADA ID: 193D11AFD7DD	Ramp Type: Perp	Initial Pass/Fail: Fail	Overall Compliance: No
Severity Score: 22.5			
Codes/Mitigation Info/Possible Solution		Field Measurements/Component Compliance

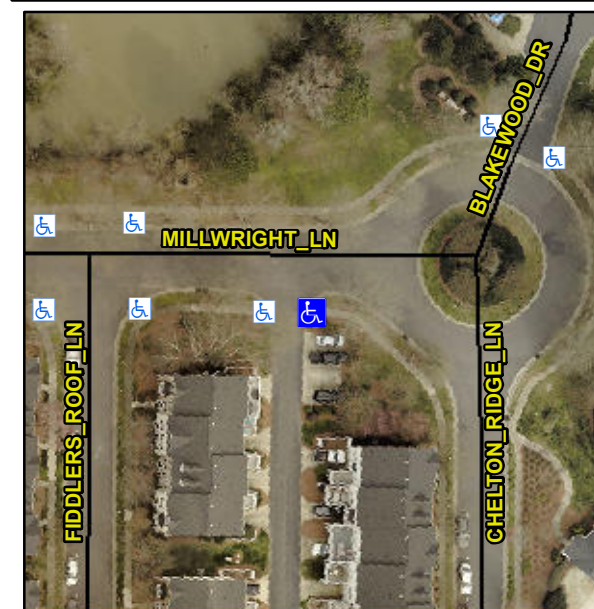
Not Found, R304.5.1, R304.2.2, R304.5.3

Compliance	Description	Data	Compliance	Description	Data
N/A	Ramp Length (in)	77.0	No	Ramp Slope (%)	11.5
No	Ramp Width (in)	43.0	No	Ramp XSlope (%)	2.4
N/A	Flare Type LT	N/A	N/A	Flare Type RT	N/A
N/A	Flare Slope LT (%)	N/A	N/A	Flare Slope RT (%)	N/A
N/A	Flare Traversable LT?	N/A	N/A	Flare Traversable RT?	N/A
N/A	Landing Length (in)	N/A	N/A	DWS Provided?	N/A
N/A	Landing Width (in)	N/A	N/A	DWS Contrast?	N/A
N/A	Landing Slope (%)	N/A	N/A	DWS Length (in)	N/A
N/A	Landing X Slope (%)	N/A	N/A	DWS Full Width?	N/A
N/A	Landing Curb? (Y/N)	N/A	N/A	DWS Offset (in)	N/A
N/A	Shared Landing?	N/A			
N/A	Gutter Ponding?	N/A	N/A	Gutter Slope (%)	N/A
N/A	Gutter Lip Ht (in)	N/A	N/A	Gutter X Slope (%)	N/A
N/A	Painted X Walk1?	No	N/A	Painted X Walk2?	N/A
	X Walk 1 Direction	To W		X Walk 2 Direction	N/A
N/A	X Walk 1 Width (in)	N/A	N/A	X Walk 2 Width (in)	N/A
	X Walk 1 Slope (%)	1.2		X Walk 2 Slope (%)	N/A
	X Walk 1 X Slope (%)	2.0		X Walk 2 X Slope (%)	N/A

N/A	Ramp inside XWalk1?	N/A	N/A	Ramp inside XWalk2?	N/A
	Road Slope (%)	N/A	N/A	Clear Space?	N/A
	Road X Slope (%)	N/A	N/A	Clear Space to XWalk (in)	N/A
N/A	Any Obstructions?	N/A	N/A	Storm Grate/Utility Hazard?	N/A
	Obstruction Type			Storm Grate/Utility Type	
		N/A			N/A
			Yes	Surface Condition? (G/P)	Good

Remove & Replace Entire Ramp.
