# Access Compliance Report

## Public Rights-of-Way

### (Curb Ramps)

Intersection ID: 7746	Main Street: ELGYWOOD_LN	Cross Street: W_ARROWHEAD_DR	Location: SE
ADA ID: 193DDB67FC8C	Ramp Type: Para	Initial Pass/Fail: Fail	Overall Compliance: No
		Severity Score: 12.5	
Codes/Mitigation Info/Possible Solution		Field Measurements/Component Compliance

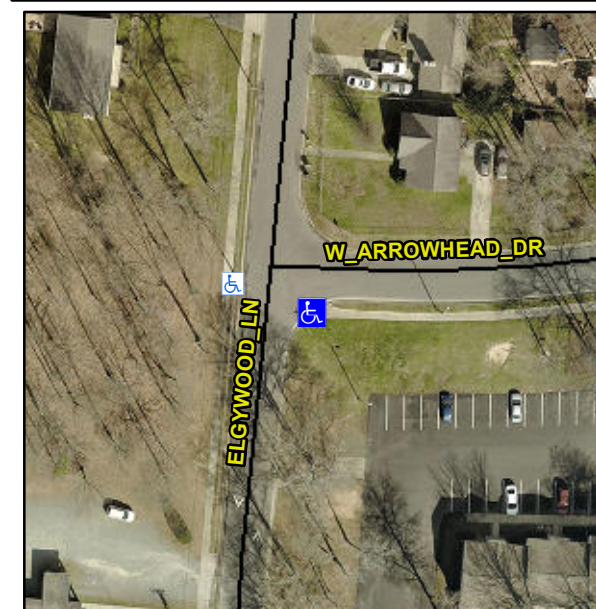
Compliance	Description	Data	Compliance	Description	Data
N/A	Ramp Length LT (in)	40.5	N/A	Ramp Length RT (in)	56.5
Yes	Ramp Width LT (in)	77.0	Yes	Ramp Width RT (in)	59.5
No	Ramp Slope LT (%)	10.0	Yes	Ramp Slope RT (%)	6.9
Yes	Ramp XSlope LT (%)	0.8	Yes	Ramp XSlope RT (%)	0.3
N/A	Landing Length (in)	N/A	N/A	DWS Provided?	N/A
N/A	Landing Width (in)	N/A	N/A	DWS Contrast?	N/A
N/A	Landing Slope (%)	N/A	N/A	DWS Length (in)	N/A
N/A	Landing X Slope (%)	N/A	N/A	DWS Full Width?	N/A
N/A	Landing Curb? (Y/N)	N/A	N/A	DWS Offset (in)	N/A
N/A	Shared Landing?	N/A			
N/A	Gutter Ponding?	N/A	N/A	Gutter Slope (%)	N/A
N/A	Gutter Lip Ht (in)	2.0	N/A	Gutter X Slope (%)	N/A
N/A	Painted X Walk1?	No	N/A	Painted X Walk2?	N/A
	X Walk 1 Direction	To SW		X Walk 2 Direction	N/A
N/A	X Walk 1 Width (in)	N/A	N/A	X Walk 2 Width (in)	N/A
	X Walk 1 Slope (%)	2.6		X Walk 2 Slope (%)	N/A
	X Walk 1 X Slope (%)	1.7		X Walk 2 X Slope (%)	N/A
N/A	Ramp inside XWalk1?	N/A	N/A	Ramp inside XWalk2?	N/A

Road Slope (%)	N/A	N/A	Clear Space?	N/A
	Road X Slope (%)	N/A	N/A	Clear Space to XWalk (in)	N/A
N/A	Any Obstructions?	N/A	N/A	Storm Grate/Utility Hazard?	N/A
	Obstruction Type			Storm Grate/Utility Type	
		N/A			N/A
			Yes	Surface Condition? (G/P)	Good
			N/A	Curb Slope (%)	24.4

Possible Solutions:

**Remove & Replace Entire Ramp.**

**R304.3.2**

**\$ 1600.00**
