# Access Compliance Report

## Public Rights-of-Way

### (Curb Ramps)

Intersection ID: 3543	Main Street: KEENELAND_LN	Cross Street: MT_HOLLY-HUNTERSVILLE_RD	Location:	E
ADA ID: 19459FC5AACA	Ramp Type: Perp	Initial Pass/Fail: Fail	Overall Compliance: No	Severity Score: 25

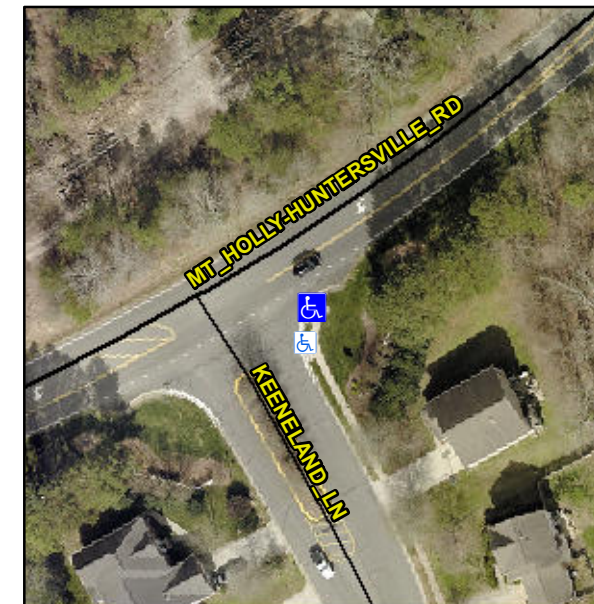
**Not Found, R304.2.2, R304.5.3**

Compliance	Description	Data	Compliance	Description	Data
N/A	Ramp Length (in)	48.5	No	Ramp Slope (%)	8.4
Yes	Ramp Width (in)	49.0	No	Ramp XSlope (%)	5.2
N/A	Flare Type LT	N/A	N/A	Flare Type RT	N/A
N/A	Flare Slope LT (%)	N/A	N/A	Flare Slope RT (%)	N/A
N/A	Flare Traversable LT?	N/A	N/A	Flare Traversable RT?	N/A
N/A	Landing Length (in)	N/A	N/A	DWS Provided?	N/A
N/A	Landing Width (in)	N/A	N/A	DWS Contrast?	N/A
N/A	Landing Slope (%)	N/A	N/A	DWS Length (in)	N/A
N/A	Landing X Slope (%)	N/A	N/A	DWS Full Width?	N/A
N/A	Landing Curb? (Y/N)	N/A	N/A	DWS Offset (in)	N/A
N/A	Shared Landing?	N/A			
N/A	Gutter Ponding?	N/A	N/A	Gutter Slope (%)	N/A
N/A	Gutter Lip Ht (in)	N/A	N/A	Gutter X Slope (%)	N/A
N/A	Painted X Walk1?	No	N/A	Painted X Walk2?	N/A
	X Walk 1 Direction	To W		X Walk 2 Direction	N/A
N/A	X Walk 1 Width (in)	N/A	N/A	X Walk 2 Width (in)	N/A
	X Walk 1 Slope (%)	6.1		X Walk 2 Slope (%)	N/A
	X Walk 1 X Slope (%)	2.4		X Walk 2 X Slope (%)	N/A

N/A	Ramp inside XWalk1?	N/A	N/A	Ramp inside XWalk2?	N/A
	Road Slope (%)	2.4	N/A	Clear Space?	N/A
	Road X Slope (%)	6.1	N/A	Clear Space to XWalk (in)	N/A
N/A	Any Obstructions?	N/A	N/A	Storm Grate/Utility Hazard?	N/A
	Obstruction Type			Storm Grate/Utility Type	
		N/A			N/A
			Yes	Surface Condition? (G/P)	Good

**Remove & Replace Entire Ramp.**

Total Cost: \$ 1850.00
