# Access Compliance Report

## Public Rights-of-Way

### (Curb Ramps)

Intersection ID: 17651	Main Street: CHELSEA_DR	Cross Street: HILLSIDE_AV	Location: SE
ADA ID: 194680DBB479	Ramp Type: Directional1	Initial Pass/Fail: Fail	Overall Compliance: No
Codes/Mitigation Info/Possible Solution		Field Measurements/Component Compliance	
Severity Score: 1.25

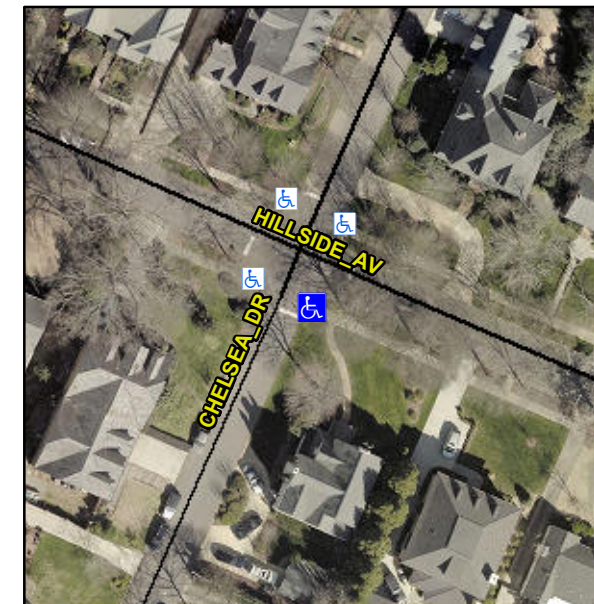
**R304.5.3**

Compliance	Description	Data	Compliance	Description	Data
N/A	Ramp Length (in)	82.0	N/A	Grade Break?	N/A
Yes	Ramp Width (in)	61.0	N/A	Grade Break Slope (%)	0.0
Yes	Ramp Slope (%)	8.2	N/A	Grade Break XSlope (%)	0.0
No	Ramp XSlope (%)	3.2			
N/A	Flare Type LT	N/A	N/A	Flare Type RT	N/A
N/A	Flare Slope LT (%)	N/A	N/A	Flare Slope RT (%)	0.0
N/A	Flare Traversable LT?	N/A	N/A	Flare Traversable RT?	N/A
N/A	Landing Length (in)	0.0	N/A	DWS Provided?	N/A
N/A	Landing Width (in)	0.0	N/A	DWS Contrast?	N/A
N/A	Landing Slope (%)	0.0	N/A	DWS Length (in)	N/A
N/A	Landing X Slope (%)	0.0	N/A	DWS Full Width?	N/A
N/A	Landing Curb? (Y/N)	N/A	N/A	DWS Offset LT (in)	N/A
N/A	Shared Landing?	N/A	N/A	DWS Offset RT (in)	N/A
N/A	Gutter Ponding?	0.0	N/A	Gutter Slope (%)	N/A
N/A	Gutter Lip Ht (in)	0.0	N/A	Gutter X Slope (%)	N/A
N/A	Painted X Walk1?	No		Road Slope (%)	4.0
	X Walk 1 Direction	To W		Road X Slope (%)	5.5
	X Walk 1 Width (in)	N/A		Clear Space?	N/A

X Walk 1 Slope (%)	4.0	N/A	Clear Space to XWalk (in)	N/A
	X Walk 1 X Slope (%)	5.5	N/A	Storm Grate/Utility Hazard?	N/A
N/A	Ramp inside XWalk1?	N/A		Storm Grate/Utility Type	
N/A	Any Obstructions?	N/A			N/A
	Obstruction Type		Yes	Surface Condition? (G/P)	Good
			N/A	Curb Slope (%)	0.4

**Remove & Replace Entire Ramp.**
