Access Compliance Report

Public Rights-of-Way

(Curb Ramps)

Intersection ID: 8611	Main Street: BROOKSHIRE_BV	Cross Street: CENTRE_ST	Location:	N
ADA ID: 1949FFD00F60	Ramp Type: BlendTrans1	Initial Pass/Fail: Fail	Overall Compliance: No	Severity Score: 10
Codes/Mitigation Info/Possible Solution		Field Measurements/Component Compliance

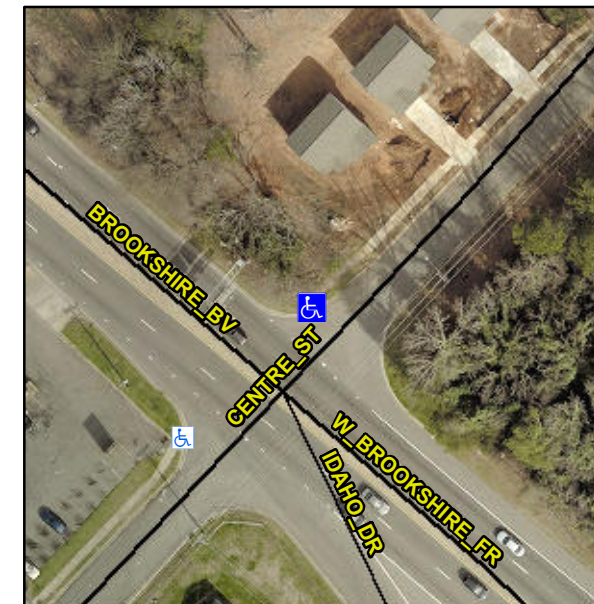
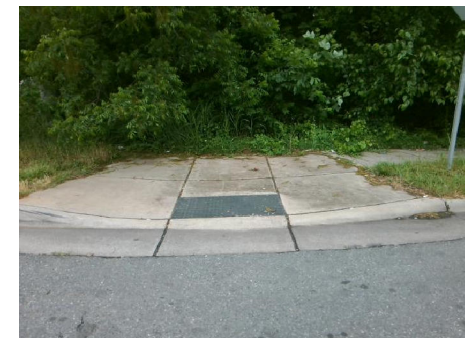
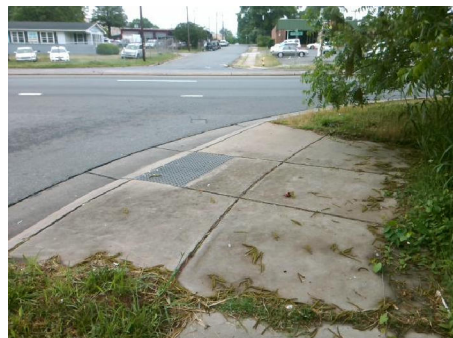
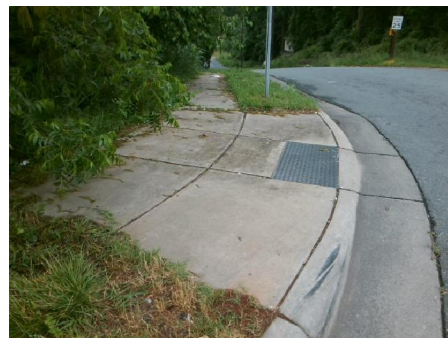
MEDIAN ACROSS BROOKSHIRE BV

Not Found, R304.5.1, R304.5.3

Compliance	Description	Data	Compliance	Description	Data
N/A	Ramp Length (in)	49.5	Yes	BlendTrans Slope (%)	3.3
No	Ramp Width (in)	47.5	No	BlendTrans XSlope (%)	3.1
N/A	Flare Type LT	N/A	N/A	Flare Type RT	N/A
N/A	Flare Slope LT (%)	N/A	N/A	Flare Slope RT (%)	N/A
N/A	Flare Traversable LT?	N/A	N/A	Flare Traversable RT?	N/A
N/A	Landing Length (in)	N/A	N/A	DWS Provided?	N/A
N/A	Landing Width (in)	N/A	N/A	DWS Contrast?	N/A
N/A	Landing Slope (%)	N/A	N/A	DWS Length (in)	N/A
N/A	Landing X Slope (%)	N/A	N/A	DWS Full Width?	N/A
N/A	Landing Curb? (Y/N)	N/A	N/A	DWS Offset (in)	N/A
N/A	Shared Landing?	N/A			
N/A	Gutter Ponding?	N/A	N/A	Gutter Slope (%)	N/A
N/A	Gutter Lip Ht (in)	3.5	N/A	Gutter X Slope (%)	N/A
N/A	Painted X Walk1?	No	N/A	Painted X Walk2?	N/A
	X Walk 1 Direction	To SE		X Walk 2 Direction	N/A
	X Walk 1 Width (in)	N/A		X Walk 2 Width (in)	N/A
	X Walk 1 Slope (%)	0.1		X Walk 2 Slope (%)	N/A
	X Walk 1 X Slope (%)	16.1		X Walk 2 X Slope (%)	N/A

N/A	Ramp inside XWalk1?	N/A	N/A	Ramp inside XWalk2?	N/A
	Road Slope (%)	9.9		Clear Space?	N/A
	Road X Slope (%)	0.1	N/A	Clear Space to XWalk (in)	N/A
N/A	Any Obstructions?	N/A	N/A	Storm Grate/Utility Hazard?	N/A
	Obstruction Type			Storm Grate/Utility Type	
		N/A			N/A
			Yes	Surface Condition? (G/P)	Good
			No	Curb Slope (%)	26.4

Possible Solutions:

Remove & Replace Curb Ramp With Two New Directional Ramps or Equivalent.
