# Access Compliance Report

## Public Rights-of-Way

### (Curb Ramps)

| Intersection ID: 53017 | Main Street: STEEL_HOUSE_BV | Cross Street: CHARTRES_LN | Location: NW |

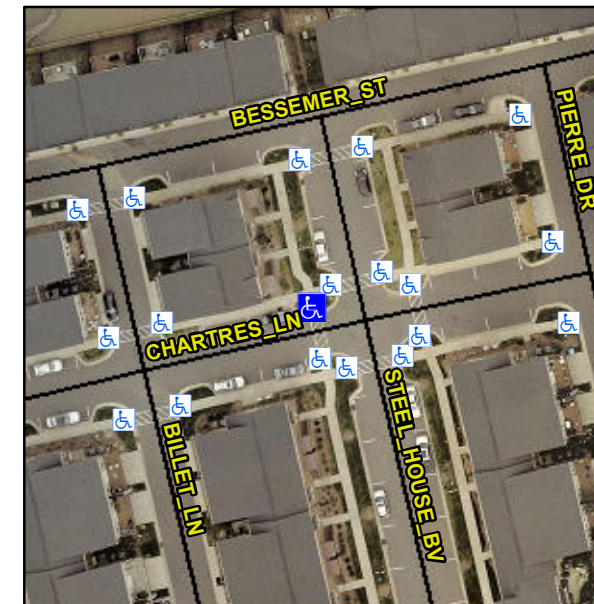
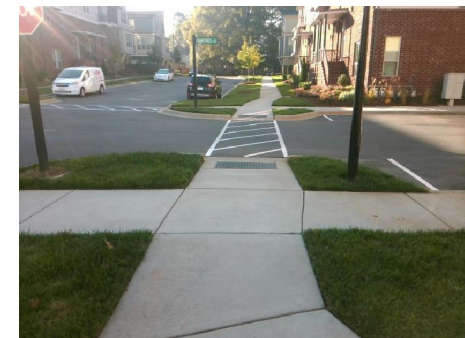
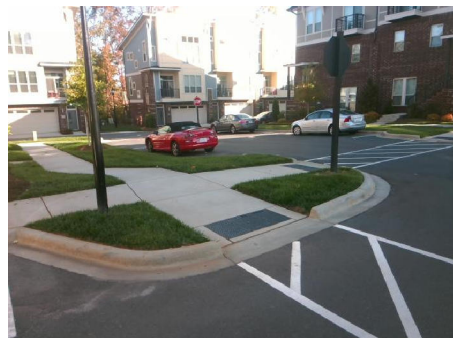
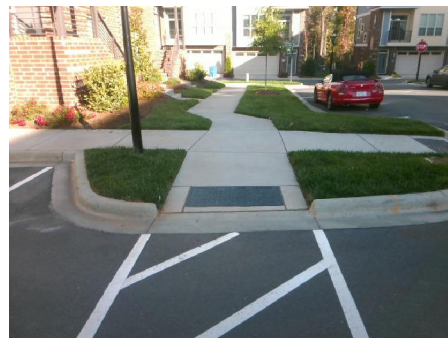
**Not Found, R305.1.4, R305.2, R302.7.2, R304.5.3**

| Compliance | Description | Data | Compliance | Description | Data |
|---|---|---|---|---|---|
| Yes | Landing X Slope (%) | 0.7 | No | DWS Full Width? | No |
| N/A | Landing Curb? (Y/N) | No | No | DWS Offset (in) | 5.0 |
| No | Gutter Lip Ht (in) | 0.3 | No | Gutter X Slope (%) | 3.0 |

**Remove & Replace Curb Ramp With Two New Directional Ramps or Equivalent. Remove & Replace Gutter.**
