Access Compliance Report Public Rights-of-Way (Curb Ramps)

Intersection ID: 10019091 Main Street: FARNSWORTH_LN Cross Street: N/A Location:

Overall Compliance: No ADA ID: 194EFB340519 Ramp Type: Perp Initial Pass/Fail: Fail Severity Score: 13.75

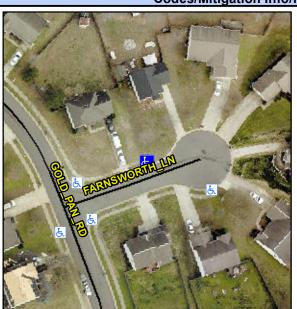
Field Measurements/Component Compliance								
	Compliance Description		Data	Comp	liance Description	Data		
	N/A	Ramp Length (in)	48.0	No	Ramp Slope (%)	10.1		
	Yes	Ramp Width (in)	49.5	Yes	Ramp XSlope (%)	4.7		
	N/A	Flare Type LT	N/A	N/A	Flare Type RT	N/A		
	N/A	Flare Slope LT (%)	N/A	N/A	Flare Slope RT (%)	N/A		
	N/A	Flare Traversable LT?	N/A	N/A	Flare Traversable RT?	N/A		
	N/A	Landing Length (in)	N/A	N/A	DWS Provided?	N/A		
	N/A	Landing Width (in)	N/A	N/A	DWS Contrast?	N/A		
	N/A	Landing Slope (%)	N/A	N/A	DWS Length (in)	N/A		
	N/A	Landing X Slope (%)	N/A	N/A	DWS Full Width?	N/A		
	N/A	Landing Curb? (Y/N)	N/A	N/A	DWS Offset (in)	N/A		
	N/A	Shared Landing?	N/A					
	N/A	Gutter Ponding?	N/A	N/A	Gutter Slope (%)	N/A		
	N/A	Gutter Lip Ht (in)	0.5	N/A	Gutter X Slope (%)	N/A		
	N/A	Painted X Walk1?	No	N/A	Painted X Walk2?	N/A		
		X Walk 1 Direction	To S		X Walk 2 Direction	N/A		
	N/A	X Walk 1 Width (in)	N/A	N/A	X Walk 2 Width (in)	N/A

X Walk 1 Slope (%)	0.7		X Walk 2 Slope (%)	N/A		
		X Walk 1 X Slope (%)	5.1		X Walk 2 X Slope (%)	N/A		
	N/A	Ramp inside XWalk1?	N/A	N/A	Ramp inside XWalk2?	N/A		
		Road Slope (%)	N/A	N/A	Clear Space?	N/A		
		Road X Slope (%)	N/A	N/A	Clear Space to XWalk (in)	N/A		
	N/A	Any Obstructions?	N/A	N/A	Storm Grate/Utility Hazard?	N/A		
		Obstruction Type			Storm Grate/Utility Type			
			N/A			N/A		
				Yes	Surface Condition? (G/P)	Good		
_

Possible Solutions:	9
Remove & Replace Entire Ramp.	ı
	١
	N
	1
	1
	ı
Surveyor Notes:	ı
N/A	ı
	1
	ı
	ı
PROW/ADA:	ı
Not Found, R304.2.2	1
	1

Total Cost: 1850.00
