# Access Compliance Report

## Public Rights-of-Way

### (Curb Ramps)

| Intersection ID: 42914 | Main Street: CROSSWALK_DR | Cross Street: FOREST_CROSS_DR | Location: S |

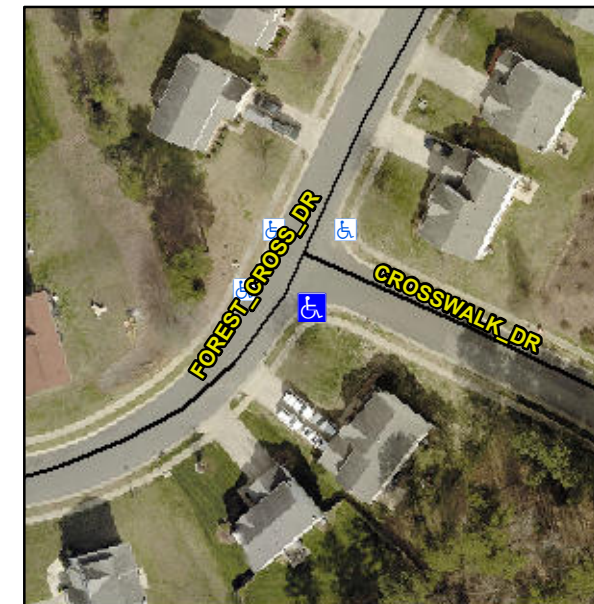
| ADA ID: 194FF995C324 | Ramp Type: PerpDiag | Initial Pass/Fail: Fail | Overall Compliance: No |

**Not Found, R304.5.1, R304.5.3**

| Compliance | Description | Data | Compliance | Description | Data |
|---|---|---|---|---|---|
| N/A | Ramp Length (in) | 47.5 | Yes | Ramp Slope (%) | 6.0 |
| No | Ramp Width (in) | 46.5 | No | Ramp XSlope (%) | 2.5 |

**Remove & Replace Curb Ramp With Two New Directional Ramps or Equivalent.**
