Access Compliance Report

Public Rights-of-Way

(Curb Ramps)

Intersection ID: 52716	Main Street: AGAVA_LN	Cross Street: MAIDENHAIR_CT	Location: W
ADA ID: 1950C0428235	Ramp Type: Perp	Initial Pass/Fail: Pass	Overall Compliance: No
Severity Score: 0			
Codes/Mitigation Info/Possible Solution		Field Measurements/Component Compliance

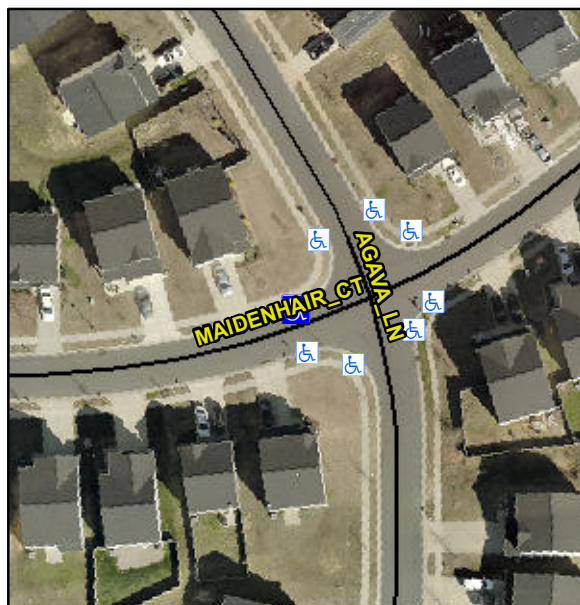
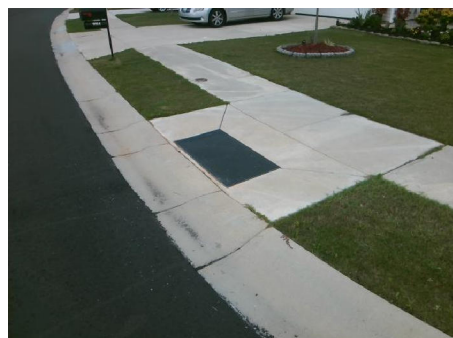
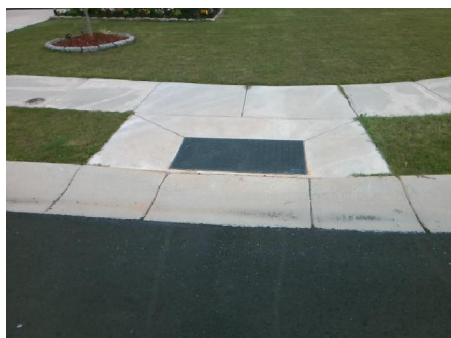
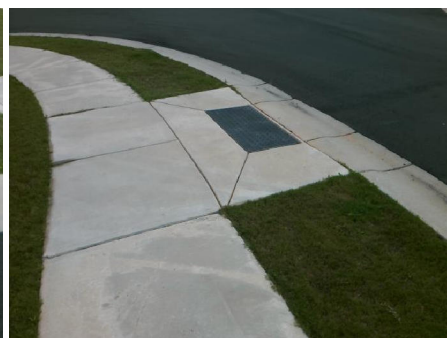
Not Found, R302.7

Compliance	Description	Data	Compliance	Description	Data
N/A	Ramp Length (in)	46.5	Yes	Ramp Slope (%)	5.2
Yes	Ramp Width (in)	48.0	Yes	Ramp XSlope (%)	0.6
N/A	Flare Type LT	Sloped	N/A	Flare Type RT	N/A
N/A	Flare Slope LT (%)	6.9	N/A	Flare Slope RT (%)	5.6
N/A	Flare Traversable LT?	No	N/A	Flare Traversable RT?	No
Yes	Landing Length (in)	48.0	Yes	DWS Provided?	Yes
Yes	Landing Width (in)	51.0	Yes	DWS Contrast?	Yes
Yes	Landing Slope (%)	0.6	Yes	DWS Length (in)	24.0
Yes	Landing X Slope (%)	1.6	Yes	DWS Full Width?	Yes
N/A	Landing Curb? (Y/N)	No	Yes	DWS Offset (in)	2.0
N/A	Shared Landing?	No			
No	Gutter Ponding?	Yes	Yes	Gutter Slope (%)	4.3
Yes	Gutter Lip Ht (in)	0.0	Yes	Gutter X Slope (%)	0.3
N/A	Painted X Walk1?	No	N/A	Painted X Walk2?	N/A
	X Walk 1 Direction	To S		X Walk 2 Direction	N/A
N/A	X Walk 1 Width (in)	N/A	N/A	X Walk 2 Width (in)	N/A
	X Walk 1 Slope (%)	2.6		X Walk 2 Slope (%)	N/A
	X Walk 1 X Slope (%)	1.3		X Walk 2 X Slope (%)	N/A

N/A	Ramp inside XWalk1?	N/A	N/A	Ramp inside XWalk2?	N/A
	Road Slope (%)	N/A	N/A	Clear Space?	Yes
	Road X Slope (%)	N/A	N/A	Clear Space to XWalk (in)	N/A
Yes	Any Obstructions?	No	Yes	Storm Grate/Utility Hazard?	No
	Obstruction Type			Storm Grate/Utility Type	
		N/A			N/A
			Yes	Surface Condition? (G/P)	Good

Possible Solutions:

Remove & Replace Entire Ramp.

Total Cost: \$ 1850.00
