Access Compliance Report

Public Rights-of-Way

(Curb Ramps)

Intersection ID: 12380	Main Street: GREAT_WAGON_RD	Cross Street: SHAMROCK_DR	Location:	N
ADA ID: 195432234F18	Ramp Type: PerpDiag	Initial Pass/Fail: Fail	Overall Compliance: No	Severity Score: 21.25

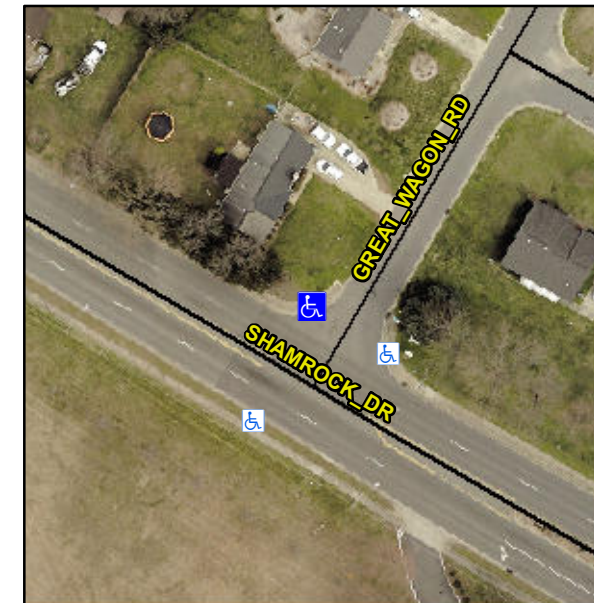
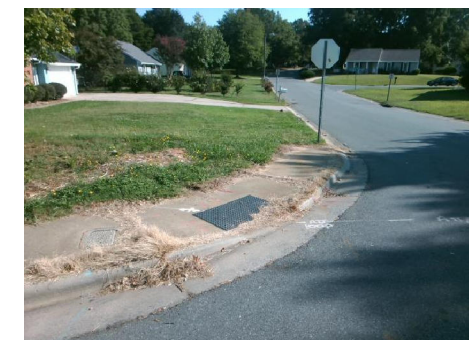
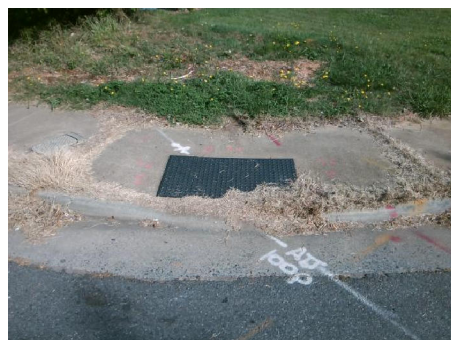
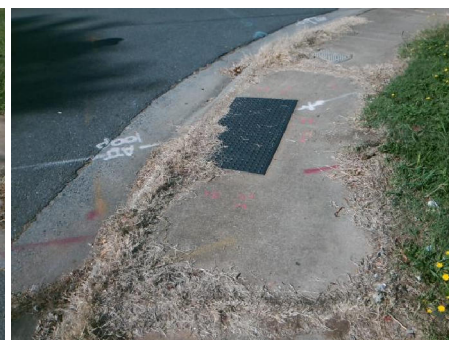
Not Found, R304.5.1, R304.5.3

Compliance	Description	Data	Compliance	Description	Data
N/A	Ramp Length (in)	59.0	Yes	Ramp Slope (%)	7.3
No	Ramp Width (in)	43.0	No	Ramp XSlope (%)	5.4
N/A	Flare Type LT	N/A	N/A	Flare Type RT	N/A
N/A	Flare Slope LT (%)	N/A	N/A	Flare Slope RT (%)	N/A
N/A	Flare Traversable LT?	N/A	N/A	Flare Traversable RT?	N/A
N/A	Landing Length (in)	N/A	N/A	DWS Provided?	N/A
N/A	Landing Width (in)	N/A	N/A	DWS Contrast?	N/A
N/A	Landing Slope (%)	N/A	N/A	DWS Length (in)	N/A
N/A	Landing X Slope (%)	N/A	N/A	DWS Full Width?	N/A
N/A	Landing Curb? (Y/N)	N/A	N/A	DWS Offset (in)	N/A
N/A	Shared Landing?	N/A			
N/A	Gutter Ponding?	Yes	N/A	Gutter Slope (%)	N/A
N/A	Gutter Lip Ht (in)	N/A	N/A	Gutter X Slope (%)	N/A
N/A	Painted X Walk1?	No	N/A	Painted X Walk2?	No
	X Walk 1 Direction	To SW		X Walk 2 Direction	To SE
N/A	X Walk 1 Width (in)	N/A	N/A	X Walk 2 Width (in)	N/A
	X Walk 1 Slope (%)	3.0		X Walk 2 Slope (%)	5.1
	X Walk 1 X Slope (%)	2.7		X Walk 2 X Slope (%)	5.5

N/A	Ramp inside XWalk1?	N/A	N/A	Ramp inside XWalk2?	N/A
	Road Slope (%)	0.8	N/A	Clear Space?	N/A
	Road X Slope (%)	9.3	N/A	Clear Space to XWalk (in)	N/A
N/A	Any Obstructions?	N/A	N/A	Storm Grate/Utility Hazard?	N/A
	Obstruction Type			Storm Grate/Utility Type	
		N/A			N/A
		Yes		Surface Condition? (G/P)	Good

Remove & Replace Curb Ramp With Two New Directional Ramps or Equivalent.
