# Access Compliance Report

## Public Rights-of-Way

### (Curb Ramps)

| Intersection ID: 18716 | Main Street: COLONY_RD | Cross Street: RUNNYMEDE_LN | Location: NW |

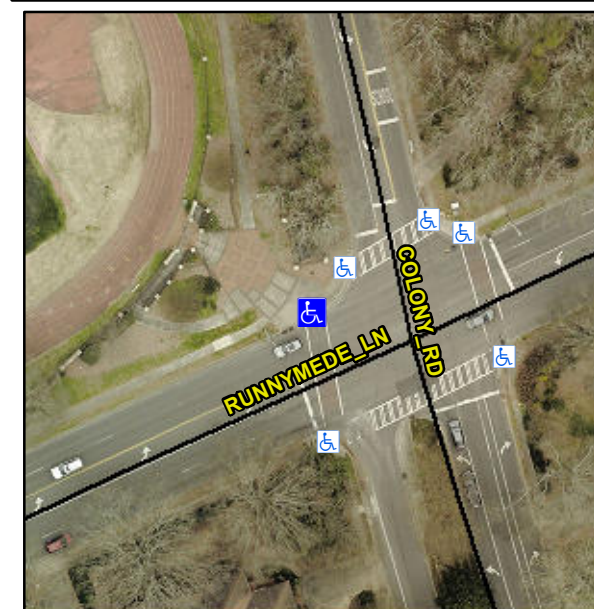
**XWALK PAVERS**

**Not Found, R304.5.3**

| Compliance | Description | Data | Compliance | Description | Data |
|---|---|---|---|---|---|
| Yes | Ramp Width (in) | 48.0 | No | BlendTrans XSlope (%) | 5.8 |

**Remove & Replace Curb Ramp With Two New Directional Ramps or Equivalent.**
