# Access Compliance Report

## Public Rights-of-Way

### (Curb Ramps)

Intersection ID: 13823	Main Street: HANOVER_ST	Cross Street: COMMONWEALTH_AV	Location:	N
ADA ID: 195760F5942B	Ramp Type: PerpDiag	Initial Pass/Fail: Fail	Overall Compliance: No	Severity Score: 12.5

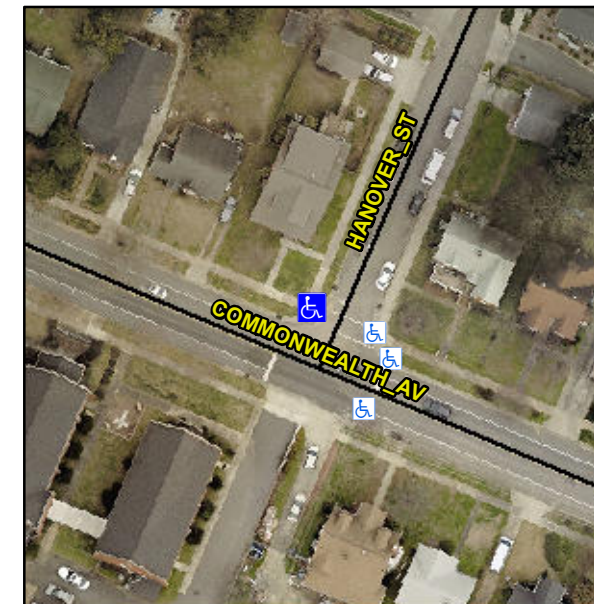
**Not Found, R304.2.2**

Compliance	Description	Data	Compliance	Description	Data
N/A	Ramp Length (in)	48.5	No	Ramp Slope (%)	8.6
Yes	Ramp Width (in)	48.0	Yes	Ramp XSlope (%)	0.4
N/A	Flare Type LT	N/A	N/A	Flare Type RT	N/A
N/A	Flare Slope LT (%)	N/A	N/A	Flare Slope RT (%)	N/A
N/A	Flare Traversable LT?	N/A	N/A	Flare Traversable RT?	N/A
N/A	Landing Length (in)	N/A	N/A	DWS Provided?	N/A
N/A	Landing Width (in)	N/A	N/A	DWS Contrast?	N/A
N/A	Landing Slope (%)	N/A	N/A	DWS Length (in)	N/A
N/A	Landing X Slope (%)	N/A	N/A	DWS Full Width?	N/A
N/A	Landing Curb? (Y/N)	N/A	N/A	DWS Offset (in)	N/A
N/A	Shared Landing?	N/A			
N/A	Gutter Ponding?	N/A	N/A	Gutter Slope (%)	N/A
N/A	Gutter Lip Ht (in)	N/A	N/A	Gutter X Slope (%)	N/A
N/A	Painted X Walk1?	No	N/A	Painted X Walk2?	Yes
	X Walk 1 Direction	To SW		X Walk 2 Direction	To SE
N/A	X Walk 1 Width (in)	N/A	N/A	X Walk 2 Width (in)	95.0
	X Walk 1 Slope (%)	3.7		X Walk 2 Slope (%)	3.1
	X Walk 1 X Slope (%)	0.9		X Walk 2 X Slope (%)	2.4

N/A	Ramp inside XWalk1?	N/A	N/A	Ramp inside XWalk2?	Yes
	Road Slope (%)	0.6	N/A	Clear Space?	N/A
	Road X Slope (%)	3.0	N/A	Clear Space to XWalk (in)	N/A
N/A	Any Obstructions?	N/A	N/A	Storm Grate/Utility Hazard?	N/A
	Obstruction Type			Storm Grate/Utility Type	
		N/A			N/A
			Yes	Surface Condition? (G/P)	Good

**Remove & Replace Curb Ramp With Two New Directional Ramps or Equivalent.**

Total Cost: \$ 3200.00
