Access Compliance Report

Public Rights-of-Way

(Curb Ramps)

Intersection ID: 10025341	Main Street: E_7TH_ST	Cross Street: N/A	Location: E
ADA ID: 195B08E4B294	Ramp Type: Para	Initial Pass/Fail: Pass	Overall Compliance: No
Severity Score: 0			
Codes/Mitigation Info/Possible Solution		Field Measurements/Component Compliance

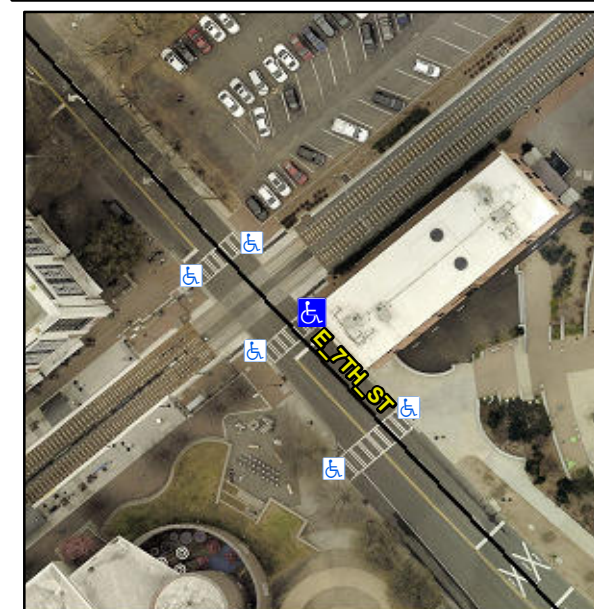
RT RP < 5%

Compliance	Description	Data	Compliance	Description	Data
N/A	Ramp Length LT (in)	N/A	N/A	Ramp Length RT (in)	118.0
N/A	Ramp Width LT (in)	N/A	Yes	Ramp Width RT (in)	73.0
N/A	Ramp Slope LT (%)	N/A	Yes	Ramp Slope RT (%)	4.9
N/A	Ramp XSlope LT (%)	N/A	Yes	Ramp XSlope RT (%)	1.3
Yes	Landing Length (in)	48.0	Yes	DWS Provided?	Yes
Yes	Landing Width (in)	59.0	Yes	DWS Contrast?	Yes
No	Landing Slope (%)	2.4	Yes	DWS Length (in)	24.0
Yes	Landing X Slope (%)	0.6	Yes	DWS Full Width?	Yes
N/A	Landing Curb? (Y/N)	No	Yes	DWS Offset (in)	1.5
N/A	Shared Landing?	No			
Yes	Gutter Ponding?	No	Yes	Gutter Slope (%)	0.9
Yes	Gutter Lip Ht (in)	0.0	Yes	Gutter X Slope (%)	1.5
N/A	Painted X Walk1?	Yes	N/A	Painted X Walk2?	N/A
	X Walk 1 Direction	To SW		X Walk 2 Direction	N/A
N/A	X Walk 1 Width (in)	111.0	N/A	X Walk 2 Width (in)	N/A
	X Walk 1 Slope (%)	1.0		X Walk 2 Slope (%)	N/A
	X Walk 1 X Slope (%)	0.7		X Walk 2 X Slope (%)	N/A
Yes	Ramp inside XWalk1?	Yes	N/A	Ramp inside XWalk2?	N/A

Road Slope (%)	N/A	N/A	Clear Space?	Yes
	Road X Slope (%)	N/A	N/A	Clear Space to XWalk (in)	N/A
Yes	Any Obstructions?	No	Yes	Storm Grate/Utility Hazard?	No
	Obstruction Type			Storm Grate/Utility Type	
		N/A			N/A
			Yes	Surface Condition? (G/P)	Good
			N/A	Curb Slope (%)	6.8

Possible Solutions:

Remove & Replace Entire Ramp.

R304.2.2-Perp, R304.3.2-Para
