Access Compliance Report Public Rights-of-Way (Curb Ramps)

Intersection ID: 17926 Main Street: N_SHARON_AMITY_RD **Cross Street: RANDOLPH RD** Location: NW ADA ID: 1974C770E2EE Ramp Type: PerpDiag Initial Pass/Fail: Fail **Overall Compliance: No Severity Score:** 25

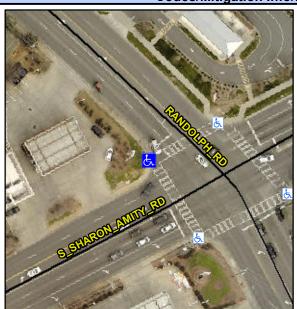
Field Measurements/Component Compliance						
Compl	iance Description	Data	Compl	iance	Description	Data
N/A	Ramp Length (in)	60.0	No	Ramp	Slope (%)	17.8
Yes	Ramp Width (in)	48.0	Yes	Ramp	XSlope (%)	0.5
N/A	Flare Type LT	N/A	N/A	Flare Type RT		N/A
N/A	Flare Slope LT (%)	N/A	N/A	Flare	Slope RT (%)	N/A
N/A	Flare Traversable LT?	N/A	N/A	Flare	Traversable RT?	N/A
N/A	Landing Length (in)	N/A	N/A	DWS	Provided?	N/A
N/A	Landing Width (in)	N/A	N/A	DWS	Contrast?	N/A
N/A	Landing Slope (%)	N/A	N/A	DWS	Length (in)	N/A
N/A	Landing X Slope (%)	N/A	N/A	DWS	Full Width?	N/A
N/A	Landing Curb? (Y/N)	N/A	N/A	DWS	Offset (in)	N/A
N/A	Shared Landing?	N/A				
N/A	Gutter Ponding?	N/A	N/A	Gutte	er Slope (%)	N/A
N/A	Gutter Lip Ht (in)	N/A	N/A	Gutte	er X Slope (%)	N/A
N/A	Painted X Walk1?	Yes	N/A	Paint	ed X Walk2?	Yes
	X Walk 1 Direction	To S		X Wa	lk 2 Direction	To E
N/A	X Walk 1 Width (in)	112.0	N/A	X Wa	lk 2 Width (in)	109.0
	X Walk 1 Slope (%)	2.6		X Wa	lk 2 Slope (%)	7.6

X Walk 1 X Slope (%)	4.3		X Wa	lk 2 X Slope (%)	0.2
N/A	Ramp inside XWalk1?	Yes	N/A	Ram	o inside XWalk2?	Yes
	Road Slope (%)	0.9	N/A	Clear	Space?	N/A
	Road X Slope (%)	4.8	N/A	Clear	Space to XWalk (in)	N/A
N/A	Any Obstructions?	N/A	N/A	Storn	n Grate/Utility Hazard?	N/A
	Obstruction Type			Storn	n Grate/Utility Type	
		N/A				N/A
				Surfa	ce Condition? (G/P)	Good

Street 1 Name N SHARON AMITY RD Stop Condition-Street 2 Signal Street 2 Name **RANDOLPH RD** Stop Condition-Street 1 Signal Possible Solutions: Remove & Replace Curb Ramp With **Two New Directional Ramps or** Equivalent. Surveyor Notes: N/A PROW/ADA: Not Found, R304.2.2

Total Cost: 3200.00
