Access Compliance Report

Public Rights-of-Way

(Curb Ramps)

Intersection ID: 46533	Main Street: GLEN_HOPE_LN	Cross Street: SUTTONVIEW_DR	Location: S
ADA ID: 198364AED4B6	Ramp Type: PerpDiag	Initial Pass/Fail: Fail	Overall Compliance: No
Severity Score: 42.5			
Codes/Mitigation Info/Possible Solution		Field Measurements/Component Compliance

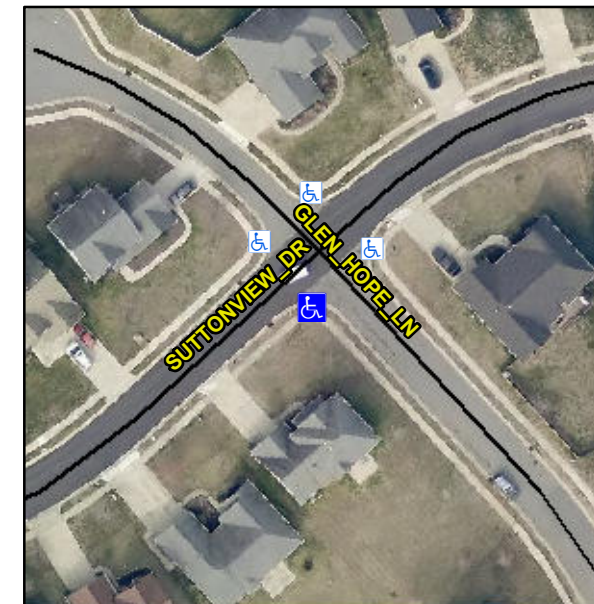
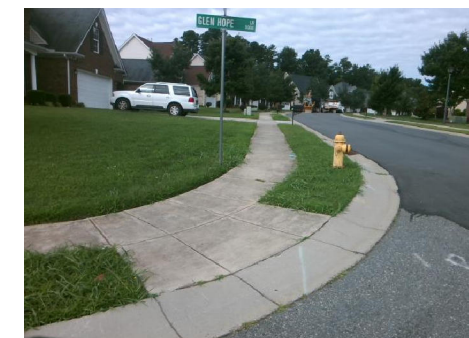
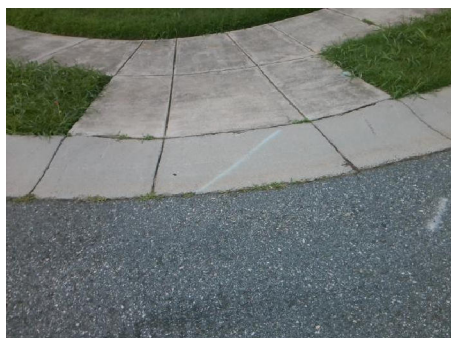
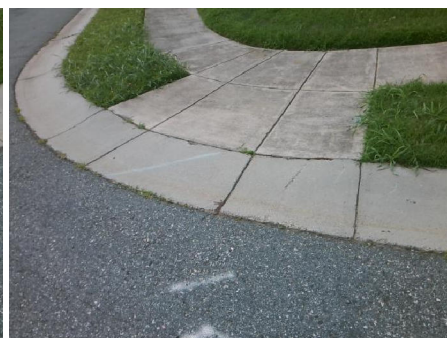
PROW/ADA:

Not Found, R304.5.1, R304.5.3

Compliance	Description	Data	Compliance	Description	Data
N/A	Ramp Length (in)	44.5	Yes	Ramp Slope (%)	5.1
No	Ramp Width (in)	33.0	No	Ramp XSlope (%)	9.9
N/A	Flare Type LT	N/A	N/A	Flare Type RT	N/A
N/A	Flare Slope LT (%)	N/A	N/A	Flare Slope RT (%)	N/A
N/A	Flare Traversable LT?	N/A	N/A	Flare Traversable RT?	N/A
N/A	Landing Length (in)	N/A	N/A	DWS Provided?	N/A
N/A	Landing Width (in)	N/A	N/A	DWS Contrast?	N/A
N/A	Landing Slope (%)	N/A	N/A	DWS Length (in)	N/A
N/A	Landing X Slope (%)	N/A	N/A	DWS Full Width?	N/A
N/A	Landing Curb? (Y/N)	N/A	N/A	DWS Offset (in)	N/A
N/A	Shared Landing?	N/A			
N/A	Gutter Ponding?	N/A	N/A	Gutter Slope (%)	N/A
N/A	Gutter Lip Ht (in)	N/A	N/A	Gutter X Slope (%)	N/A
N/A	Painted X Walk1?	No	N/A	Painted X Walk2?	No
	X Walk 1 Direction	To NE		X Walk 2 Direction	To NW
N/A	X Walk 1 Width (in)	N/A	N/A	X Walk 2 Width (in)	N/A
	X Walk 1 Slope (%)	2.2		X Walk 2 Slope (%)	9.5
	X Walk 1 X Slope (%)	6.5		X Walk 2 X Slope (%)	2.8

N/A	Ramp inside XWalk1?	N/A	N/A	Ramp inside XWalk2?	N/A
	Road Slope (%)	8.1	N/A	Clear Space?	N/A
	Road X Slope (%)	1.0	N/A	Clear Space to XWalk (in)	N/A
N/A	Any Obstructions?	N/A	N/A	Storm Grate/Utility Hazard?	N/A
	Obstruction Type			Storm Grate/Utility Type	
		N/A			N/A
			Yes	Surface Condition? (G/P)	Good

Possible Solutions:

Remove & Replace Curb Ramp With Two New Directional Ramps or Equivalent.
