Access Compliance Report

Public Rights-of-Way

(Curb Ramps)

Intersection ID: 25926	Main Street: ALDERMAN_LN	Cross Street: NEWCOMBE_CT	Location: NE
ADA ID: 1985FD9DEF29	Ramp Type: PerpDiag	Initial Pass/Fail: Fail	Overall Compliance: No
Severity Score: 22.5			
Codes/Mitigation Info/Possible Solution		Field Measurements/Component Compliance

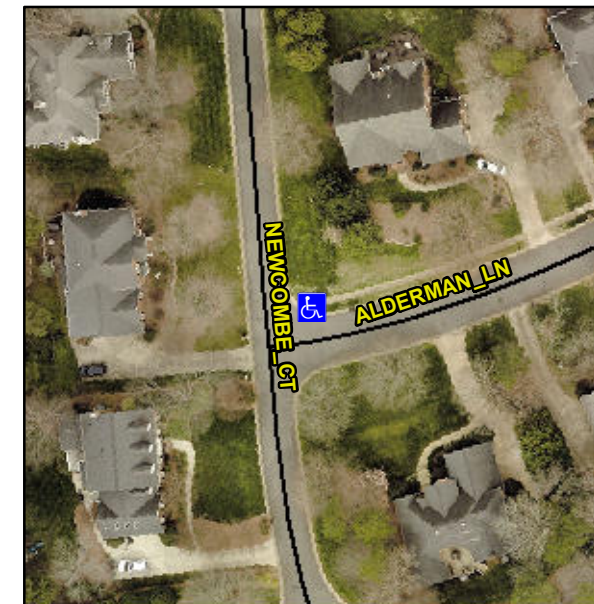
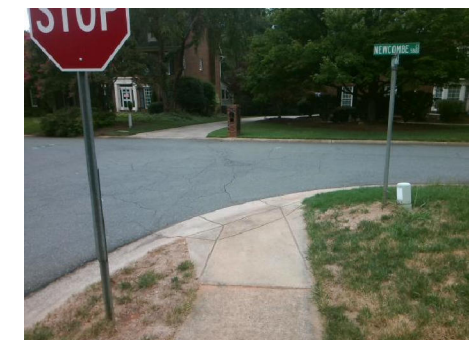
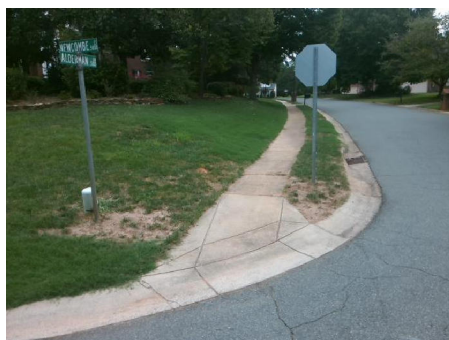
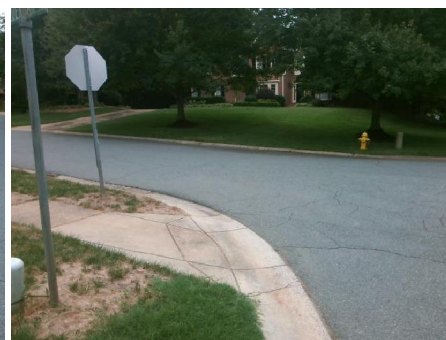
Not Found, R304.5.1, R304.2.2, R304.5.3

Compliance	Description	Data	Compliance	Description	Data
N/A	Ramp Length (in)	76.0	No	Ramp Slope (%)	10.2
No	Ramp Width (in)	38.0	No	Ramp XSlope (%)	3.1
N/A	Flare Type LT	N/A	N/A	Flare Type RT	N/A
N/A	Flare Slope LT (%)	N/A	N/A	Flare Slope RT (%)	N/A
N/A	Flare Traversable LT?	N/A	N/A	Flare Traversable RT?	N/A
N/A	Landing Length (in)	N/A	N/A	DWS Provided?	N/A
N/A	Landing Width (in)	N/A	N/A	DWS Contrast?	N/A
N/A	Landing Slope (%)	N/A	N/A	DWS Length (in)	N/A
N/A	Landing X Slope (%)	N/A	N/A	DWS Full Width?	N/A
N/A	Landing Curb? (Y/N)	N/A	N/A	DWS Offset (in)	N/A
N/A	Shared Landing?	N/A			
N/A	Gutter Ponding?	N/A	N/A	Gutter Slope (%)	N/A
N/A	Gutter Lip Ht (in)	N/A	N/A	Gutter X Slope (%)	N/A
N/A	Painted X Walk1?	No	N/A	Painted X Walk2?	No
	X Walk 1 Direction	To W		X Walk 2 Direction	To S
N/A	X Walk 1 Width (in)	N/A	N/A	X Walk 2 Width (in)	N/A
	X Walk 1 Slope (%)	2.9		X Walk 2 Slope (%)	4.0
	X Walk 1 X Slope (%)	1.3		X Walk 2 X Slope (%)	0.0

N/A	Ramp inside XWalk1?	N/A	N/A	Ramp inside XWalk2?	N/A
	Road Slope (%)	1.5	N/A	Clear Space?	N/A
	Road X Slope (%)	2.9	N/A	Clear Space to XWalk (in)	N/A
N/A	Any Obstructions?	N/A	N/A	Storm Grate/Utility Hazard?	N/A
	Obstruction Type			Storm Grate/Utility Type	
		N/A			N/A
		Yes		Surface Condition? (G/P)	Good

Remove & Replace Curb Ramp With Two New Directional Ramps or Equivalent.
