# Access Compliance Report

## Public Rights-of-Way

### (Curb Ramps)

| Intersection ID: 19862 | | Main Street: EASTHAM_LN | | Cross Street: WINTERCREST_LN | | Location: | | NW | |

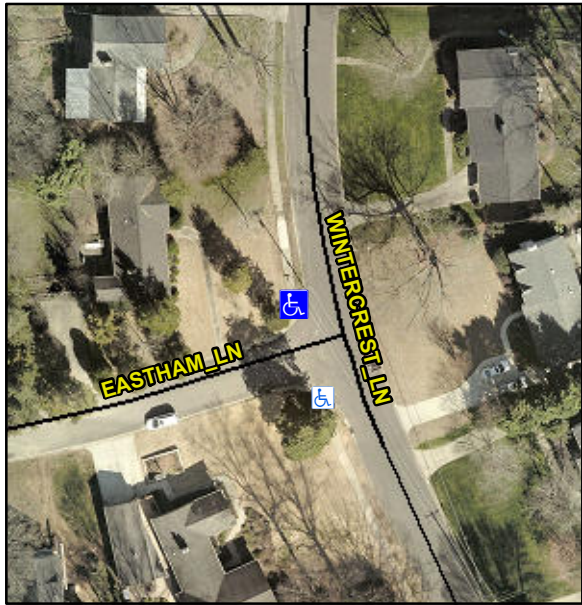
| ADA ID: 198ABCF92667 | | Ramp Type: Directional1 | | Initial Pass/Fail: Pass | | Overall Compliance: No | | Severity Score: 2.5 | |
| | | | | No | Landing Length (in) | 35.0 | Yes | DWS Provided? | Yes |
| | | | | No | Landing Slope (%) | 7.1 | Yes | DWS Length (in) | 24.5 |
| | | | | No | Landing X Slope (%) | 4.0 | No | DWS Full Width? | No |
| | | | | N/A | Landing Curb? (Y/N) | No | No | DWS Offset LT (in) | 68.0 |
| | | | | N/A | Shared Landing? | No | No | DWS Offset RT (in) | 5.0 |
| | | | | Yes | Gutter Lip Ht (in) | 0.0 | No | Gutter X Slope (%) | 4.4 |

| <div></div> <div>Possible Solutions:</div> <div>Remove &amp; Replace Entire Ramp.<br/>Remove &amp; Replace Gutter.</div> <div>Surveyor Notes:</div> <div>N/A</div> <div>PROW/ADA:</div> <div>R304.2.1, R304.2.2-Perp, R304.3.2-Para, R304.5.3, R305.1.4, R305.2</div> <div>Street 1 Name</div> <div>EASTHAM LN</div> <div>Stop Condition-Street 1</div> <div>StopSign</div> <div>Street 2 Name</div> <div>N/A</div> <div>Stop Condition-Street 2</div> <div>N/A</div> <div>Total Cost:</div> <div>\$</div> <div>2350.00</div> | | | | Compliance | Description | Data | Compliance | Description | Data |
