Access Compliance Report

Public Rights-of-Way

(Curb Ramps)

Intersection ID: 10457	Main Street: GALWAY_DR	Cross Street: RUTH_DR	Location: SE
ADA ID: 198BA94A79B7	Ramp Type: Directional1	Initial Pass/Fail: Pass	Overall Compliance: No
Codes/Mitigation Info/Possible Solution		Field Measurements/Component Compliance	
Severity Score: 22.5

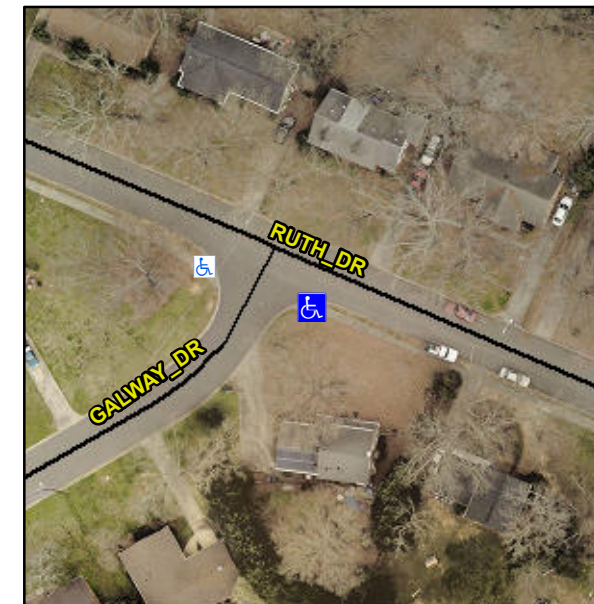
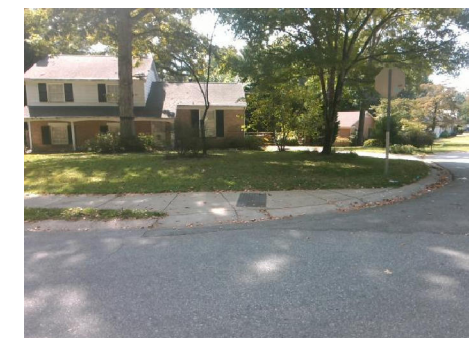
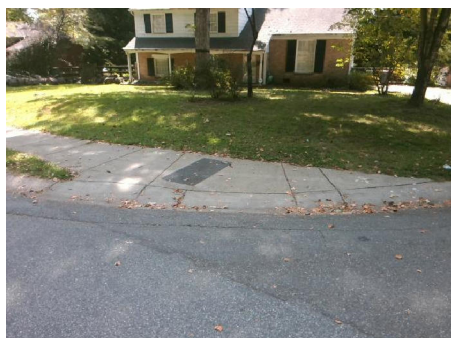
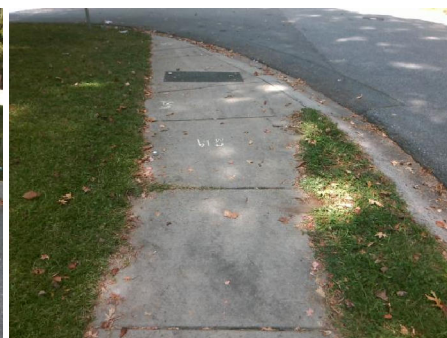
**Not Found, R304.2.2-Perp, R304.3.2-
Para, R304.5.3, R305.1.4, R305.2,
R302.7.2, R304.5.4**

Compliance	Description	Data	Compliance	Description	Data
N/A	Ramp Length (in)	168.0	N/A	Grade Break?	N/A
Yes	Ramp Width (in)	60.0	N/A	Grade Break Slope (%)	0.0
Yes	Ramp Slope (%)	3.7	N/A	Grade Break XSlope (%)	0.0
Yes	Ramp XSlope (%)	1.9			
N/A	Flare Type LT	N/A	N/A	Flare Type RT	N/A
Yes	Flare Slope LT (%)	0.4	N/A	Flare Slope RT (%)	1.8
N/A	Flare Traversable LT?	Yes	N/A	Flare Traversable RT?	No
Yes	Landing Length (in)	49.5	Yes	DWS Provided?	Yes
Yes	Landing Width (in)	60.0	Yes	DWS Contrast?	Yes
No	Landing Slope (%)	4.2	Yes	DWS Length (in)	24.0
No	Landing X Slope (%)	2.6	No	DWS Full Width?	No
N/A	Landing Curb? (Y/N)	No	No	DWS Offset LT (in)	12.0
N/A	Shared Landing?	No	No	DWS Offset RT (in)	97.0
Yes	Gutter Ponding?	No	No	Gutter Slope (%)	11.6
No	Gutter Lip Ht (in)	2.0	No	Gutter X Slope (%)	2.5
N/A	Painted X Walk1?	No		Road Slope (%)	3.0
	X Walk 1 Direction	To NW		Road X Slope (%)	2.8
	X Walk 1 Width (in)	N/A		Clear Space?	Yes

X Walk 1 Slope (%)	3.0	N/A	Clear Space to XWalk (in)	N/A
	X Walk 1 X Slope (%)	2.8	Yes	Storm Grate/Utility Hazard?	No
N/A	Ramp inside XWalk1?	N/A		Storm Grate/Utility Type	
Yes	Any Obstructions?	No			N/A
	Obstruction Type		Yes	Surface Condition? (G/P)	Good
			N/A	Curb Slope (%)	15.6

**Remove & Replace Entire Ramp.
Remove & Replace Gutter.**
