Access Compliance Report

Public Rights-of-Way

(Curb Ramps)

Intersection ID: 52929	Main Street: ENGLISH_OAK_LEAF_CT	Cross Street: GRAY_OAK_LN	Location: W
ADA ID: 198BDA389F71	Ramp Type: BlendTrans1	Initial Pass/Fail: Fail	Overall Compliance: No
Codes/Mitigation Info/Possible Solution			Severity Score: 10
			Field Measurements/Component Compliance

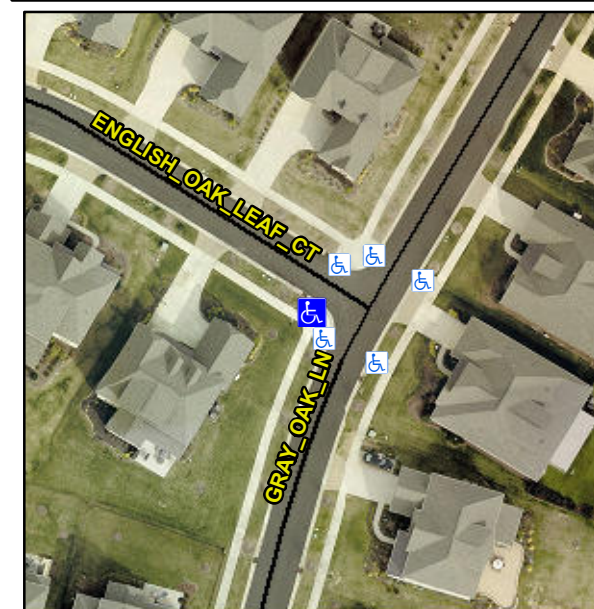
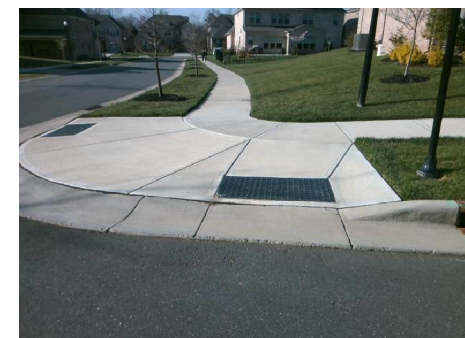
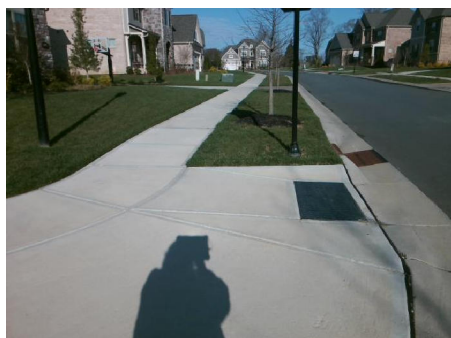
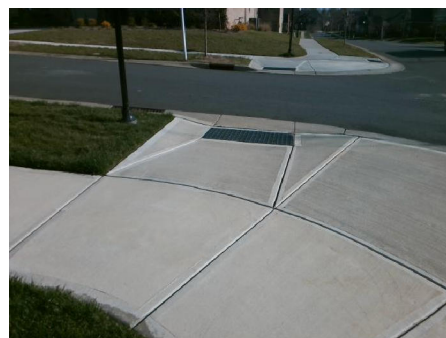
Compliance	Description	Data	Compliance	Description	Data
N/A	Ramp Length (in)	88.0	Yes	BlendTrans Slope (%)	1.6
No	Ramp Width (in)	47.5	No	BlendTrans XSlope (%)	4.8
N/A	Flare Type LT	N/A	N/A	Flare Type RT	N/A
N/A	Flare Slope LT (%)	N/A	N/A	Flare Slope RT (%)	N/A
N/A	Flare Traversable LT?	N/A	N/A	Flare Traversable RT?	N/A
N/A	Landing Length (in)	N/A	N/A	DWS Provided?	N/A
N/A	Landing Width (in)	N/A	N/A	DWS Contrast?	N/A
N/A	Landing Slope (%)	N/A	N/A	DWS Length (in)	N/A
N/A	Landing X Slope (%)	N/A	N/A	DWS Full Width?	N/A
N/A	Landing Curb? (Y/N)	N/A	N/A	DWS Offset (in)	N/A
N/A	Shared Landing?	N/A			
N/A	Gutter Ponding?	N/A	N/A	Gutter Slope (%)	N/A
N/A	Gutter Lip Ht (in)	N/A	N/A	Gutter X Slope (%)	N/A
N/A	Painted X Walk1?	No	N/A	Painted X Walk2?	N/A
	X Walk 1 Direction	To NE		X Walk 2 Direction	N/A
	X Walk 1 Width (in)	N/A		X Walk 2 Width (in)	N/A
	X Walk 1 Slope (%)	1.0		X Walk 2 Slope (%)	N/A
	X Walk 1 X Slope (%)	2.5		X Walk 2 X Slope (%)	N/A

N/A	Ramp inside XWalk1?	N/A	N/A	Ramp inside XWalk2?	N/A
	Road Slope (%)	2.5		Clear Space?	N/A
	Road X Slope (%)	1.0	N/A	Clear Space to XWalk (in)	N/A
N/A	Any Obstructions?	N/A	N/A	Storm Grate/Utility Hazard?	N/A
	Obstruction Type			Storm Grate/Utility Type	
		N/A			N/A
			Yes	Surface Condition? (G/P)	Good
			N/A	Curb Slope (%)	0.1

Possible Solutions:

Remove & Replace Curb Ramp With Two New Directional Ramps or Equivalent.

R304.5.1, R304.5.3
