# Access Compliance Report

## Public Rights-of-Way

### (Curb Ramps)

| Intersection ID: 28352 | Main Street: LEDGER_CT | Cross Street: TONAWANDA_DR | Location: | E |

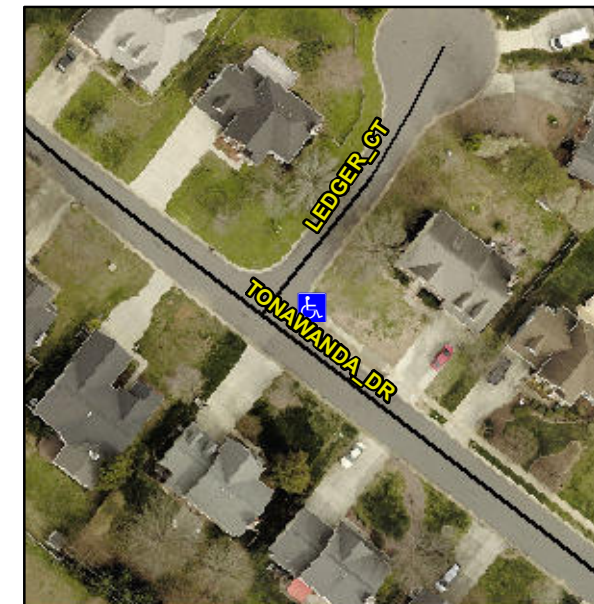
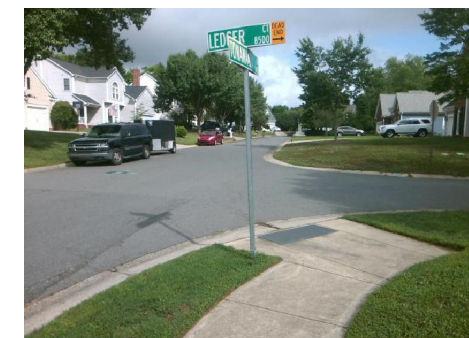
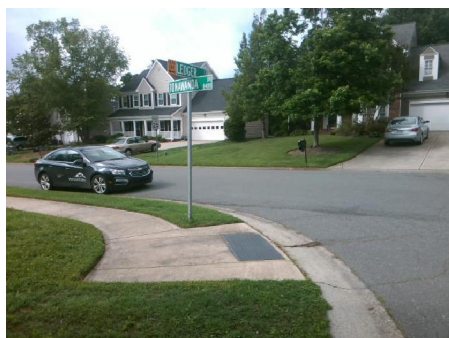
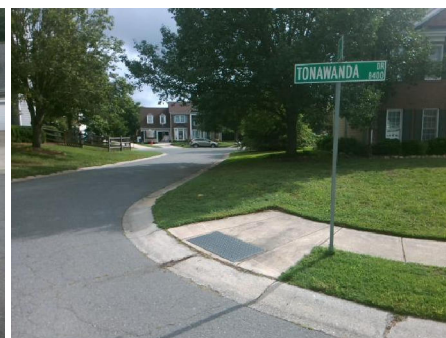
| ADA ID: 1990F3AD25E1 | Ramp Type: Perp | Initial Pass/Fail: Fail | Overall Compliance: No | Severity Score: 10 |

**Not Found, R304.5.1, R304.5.3**

| Compliance | Description | Data | Compliance | Description | Data |
|---|---|---|---|---|---|
| N/A | Ramp Length (in) | 93.5 | Yes | Ramp Slope (%) | 5.3 |
| No | Ramp Width (in) | 41.5 | No | Ramp XSlope (%) | 2.3 |

**Remove & Replace Entire Ramp.**

Total Cost: \$ 1850.00
