Access Compliance Report

Public Rights-of-Way

(Curb Ramps)

Intersection ID: N/A	Main Street: LITTLE ROCK RD	Cross Street: N/A	Location: SW
ADA ID: 19991A2E6335	Ramp Type: BlendTrans2	Initial Pass/Fail: Pass	Overall Compliance: No
Severity Score: 0.25			
Codes/Mitigation Info/Possible Solution		Field Measurements/Component Compliance

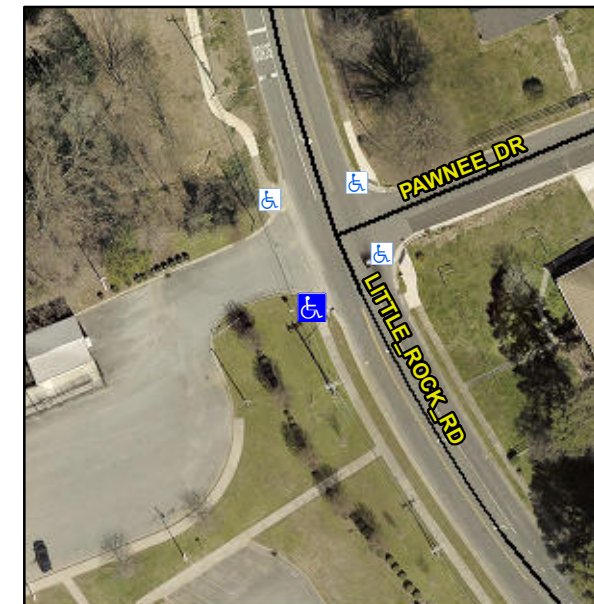
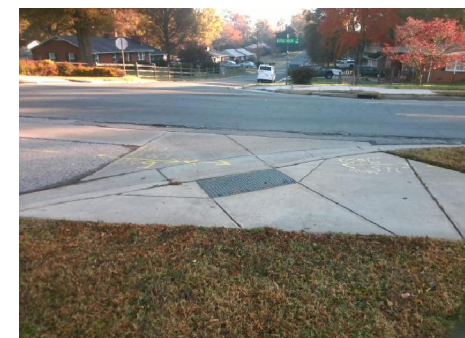
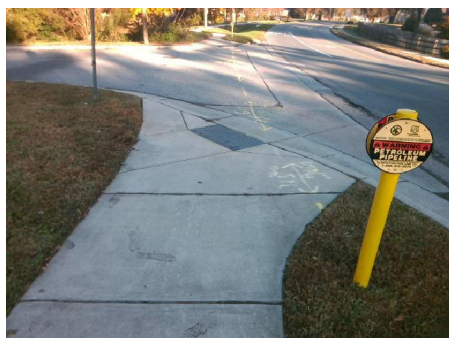
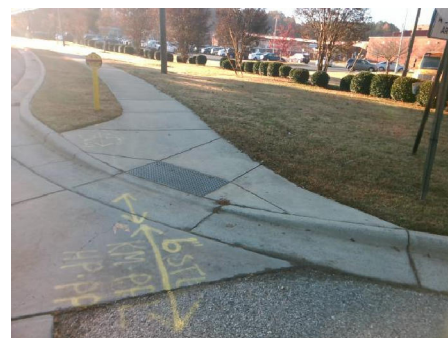
Compliance	Description	Data	Compliance	Description	Data
N/A	Ramp Length (in)	61.0	Yes	BlendTrans Slope (%)	4.1
Yes	Ramp Width (in)	48.0	No	BlendTrans XSlope (%)	2.4
N/A	Flare Type LT	Sloped	N/A	Flare Type RT	Sloped
N/A	Flare Slope LT (%)	8.1	N/A	Flare Slope RT (%)	3.9
N/A	Flare Traversable LT?	No	N/A	Flare Traversable RT?	No
N/A	Landing Length (in)	N/A	Yes	DWS Provided?	Yes
N/A	Landing Width (in)	N/A	Yes	DWS Contrast?	Yes
N/A	Landing Slope (%)	N/A	Yes	DWS Length (in)	24.0
N/A	Landing X Slope (%)	N/A	Yes	DWS Full Width?	Yes
N/A	Landing Curb? (Y/N)	No	Yes	DWS Offset (in)	1.0
N/A	Shared Landing?	No			
Yes	Gutter Ponding?	No	Yes	Gutter Slope (%)	2.6
Yes	Gutter Lip Ht (in)	0.0	Yes	Gutter X Slope (%)	0.5
N/A	Painted X Walk1?	No	N/A	Painted X Walk2?	No
	X Walk 1 Direction	To NE		X Walk 2 Direction	To N
	X Walk 1 Width (in)	N/A		X Walk 2 Width (in)	N/A
	X Walk 1 Slope (%)	0.4		X Walk 2 Slope (%)	0.6
	X Walk 1 X Slope (%)	1.8		X Walk 2 X Slope (%)	0.3

N/A	Ramp inside XWalk1?	N/A	N/A	Ramp inside XWalk2?	N/A
	Road Slope (%)	0.7		Clear Space?	Yes
	Road X Slope (%)	0.6	N/A	Clear Space to XWalk (in)	N/A
Yes	Any Obstructions?	No	Yes	Storm Grate/Utility Hazard?	No
	Obstruction Type			Storm Grate/Utility Type	
		N/A			N/A
			Yes	Surface Condition? (G/P)	Good
			N/A	Curb Slope (%)	2.2

Possible Solutions:

Remove & Replace Curb Ramp With Two New Directional Ramps or Equivalent.

R304.5.3
