# Access Compliance Report

## Public Rights-of-Way

### (Curb Ramps)

Intersection ID: 44003	Main Street: FELICITY_CT	Cross Street: ELROSE_PL	Location: SE
ADA ID: 1999A7BD4A6D	Ramp Type: BlendTrans1	Initial Pass/Fail: Fail	Overall Compliance: No
		Severity Score: 33.75

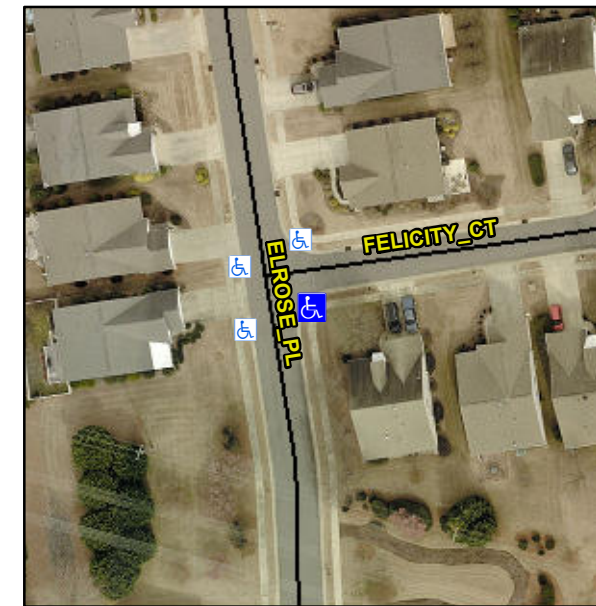
**Not Found, R304.5.1, R304.5.3**

Compliance	Description	Data	Compliance	Description	Data
N/A	Ramp Length (in)	47.0	Yes	BlendTrans Slope (%)	3.3
No	Ramp Width (in)	47.0	No	BlendTrans XSlope (%)	7.5
N/A	Flare Type LT	N/A	N/A	Flare Type RT	N/A
N/A	Flare Slope LT (%)	N/A	N/A	Flare Slope RT (%)	N/A
N/A	Flare Traversable LT?	N/A	N/A	Flare Traversable RT?	N/A
N/A	Landing Length (in)	N/A	N/A	DWS Provided?	N/A
N/A	Landing Width (in)	N/A	N/A	DWS Contrast?	N/A
N/A	Landing Slope (%)	N/A	N/A	DWS Length (in)	N/A
N/A	Landing X Slope (%)	N/A	N/A	DWS Full Width?	N/A
N/A	Landing Curb? (Y/N)	N/A	N/A	DWS Offset (in)	N/A
N/A	Shared Landing?	N/A			
N/A	Gutter Ponding?	N/A	N/A	Gutter Slope (%)	N/A
N/A	Gutter Lip Ht (in)	N/A	N/A	Gutter X Slope (%)	N/A
N/A	Painted X Walk1?	No	N/A	Painted X Walk2?	No
	X Walk 1 Direction	To N		X Walk 2 Direction	To W
	X Walk 1 Width (in)	N/A		X Walk 2 Width (in)	N/A
	X Walk 1 Slope (%)	2.2		X Walk 2 Slope (%)	5.3
	X Walk 1 X Slope (%)	7.7		X Walk 2 X Slope (%)	0.9

N/A	Ramp inside XWalk1?	N/A	N/A	Ramp inside XWalk2?	N/A
	Road Slope (%)	4.7		Clear Space?	N/A
	Road X Slope (%)	5.9	N/A	Clear Space to XWalk (in)	N/A
N/A	Any Obstructions?	N/A	N/A	Storm Grate/Utility Hazard?	N/A
	Obstruction Type			Storm Grate/Utility Type	
		N/A			N/A
			Yes	Surface Condition? (G/P)	Good
			No	Curb Slope (%)	16.3

**Remove & Replace Curb Ramp With Two New Directional Ramps or Equivalent.**
