# Access Compliance Report

## Public Rights-of-Way

| Intersection ID: 24381 | Main Street: MIROW_PL | Cross Street: STARGARD_CT | Location: S |
| ADA ID: 19A953AAF82C | Ramp Type: PerpDiag | Initial Pass/Fail: Fail | Overall Compliance: No |

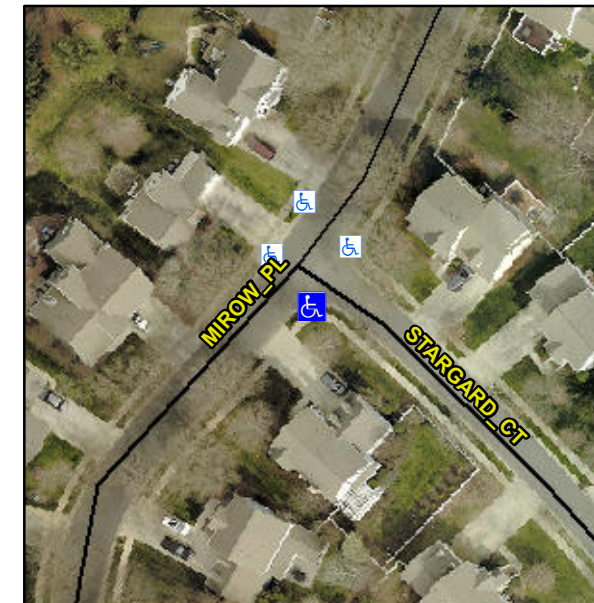
| | | Severity Score: 12.5 | |

**Not Found, R304.5.3**

| Compliance | Description | Data | Compliance | Description | Data |
|---|---|---|---|---|---|
| Yes | Ramp Width (in) | 48.0 | No | Ramp XSlope (%) | 6.5 |

**Remove & Replace Curb Ramp With Two New Directional Ramps or Equivalent.**

Total Cost: \$ 3200.00
