# Access Compliance Report

## Public Rights-of-Way

### (Curb Ramps)

Intersection ID: 19443	Main Street: ECHODALE_DR	Cross Street: ELLENDALE_DR	Location:	NW
ADA ID: 19BBE4455839	Ramp Type: Directional1	Initial Pass/Fail: Fail	Overall Compliance: No	Severity Score: 8.75
Codes/Mitigation Info/Possible Solution		Field Measurements/Component Compliance

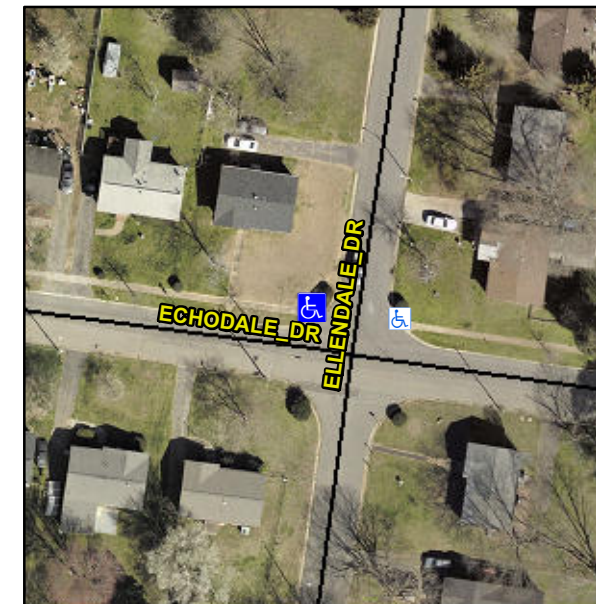
Compliance	Description	Data	Compliance	Description	Data
N/A	Ramp Length (in)	83.0	N/A	Grade Break?	N/A
No	Ramp Width (in)	41.0	N/A	Grade Break Slope (%)	0.0
Yes	Ramp Slope (%)	6.1	N/A	Grade Break XSlope (%)	0.0
Yes	Ramp XSlope (%)	1.0			
N/A	Flare Type LT	N/A	N/A	Flare Type RT	N/A
N/A	Flare Slope LT (%)	N/A	N/A	Flare Slope RT (%)	0.0
N/A	Flare Traversable LT?	N/A	N/A	Flare Traversable RT?	N/A
N/A	Landing Length (in)	0.0	N/A	DWS Provided?	N/A
N/A	Landing Width (in)	0.0	N/A	DWS Contrast?	N/A
N/A	Landing Slope (%)	0.0	N/A	DWS Length (in)	N/A
N/A	Landing X Slope (%)	0.0	N/A	DWS Full Width?	N/A
N/A	Landing Curb? (Y/N)	N/A	N/A	DWS Offset LT (in)	N/A
N/A	Shared Landing?	N/A	N/A	DWS Offset RT (in)	N/A
N/A	Gutter Ponding?	0.0	N/A	Gutter Slope (%)	N/A
N/A	Gutter Lip Ht (in)	0.0	N/A	Gutter X Slope (%)	N/A
N/A	Painted X Walk1?	No		Road Slope (%)	2.1
	X Walk 1 Direction	To NE		Road X Slope (%)	0.3
	X Walk 1 Width (in)	N/A		Clear Space?	N/A

X Walk 1 Slope (%)	2.1	N/A	Clear Space to XWalk (in)	N/A
	X Walk 1 X Slope (%)	0.3	N/A	Storm Grate/Utility Hazard?	N/A
N/A	Ramp inside XWalk1?	N/A		Storm Grate/Utility Type	
N/A	Any Obstructions?	N/A			N/A
	Obstruction Type		Yes	Surface Condition? (G/P)	Good
			N/A	Curb Slope (%)	11.8

Possible Solutions:

**Remove & Replace Entire Ramp.**
