Access Compliance Report

Public Rights-of-Way

(Curb Ramps)

Intersection ID: 31686	Main Street: GALLISON_AV	Cross Street: SNOWDROP_DR	Location: NW
ADA ID: 19BDF45DB436	Ramp Type: PerpDiag	Initial Pass/Fail: Fail	Overall Compliance: No
Severity Score: 21.25			
Codes/Mitigation Info/Possible Solution		Field Measurements/Component Compliance

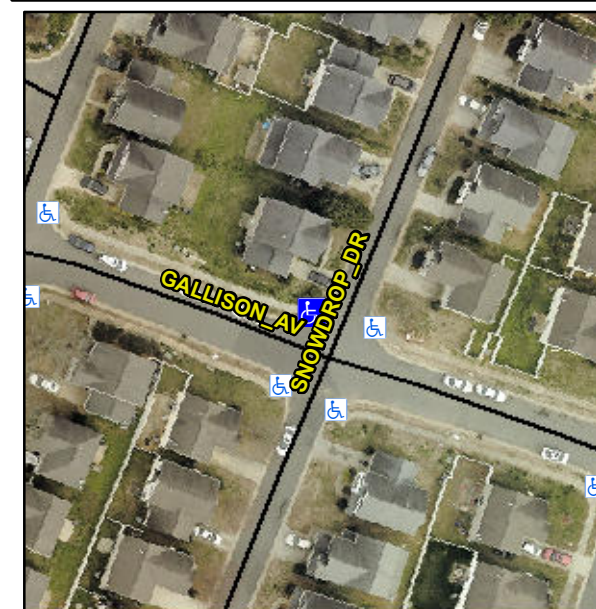
Compliance	Description	Data	Compliance	Description	Data
N/A	Ramp Length (in)	48.0	Yes	Ramp Slope (%)	7.7
No	Ramp Width (in)	36.0	No	Ramp XSlope (%)	6.6
N/A	Flare Type LT	N/A	N/A	Flare Type RT	N/A
N/A	Flare Slope LT (%)	N/A	N/A	Flare Slope RT (%)	N/A
N/A	Flare Traversable LT?	N/A	N/A	Flare Traversable RT?	N/A
N/A	Landing Length (in)	N/A	N/A	DWS Provided?	N/A
N/A	Landing Width (in)	N/A	N/A	DWS Contrast?	N/A
N/A	Landing Slope (%)	N/A	N/A	DWS Length (in)	N/A
N/A	Landing X Slope (%)	N/A	N/A	DWS Full Width?	N/A
N/A	Landing Curb? (Y/N)	N/A	N/A	DWS Offset (in)	N/A
N/A	Shared Landing?	N/A			
N/A	Gutter Ponding?	N/A	N/A	Gutter Slope (%)	N/A
N/A	Gutter Lip Ht (in)	N/A	N/A	Gutter X Slope (%)	N/A
N/A	Painted X Walk1?	No	N/A	Painted X Walk2?	No
	X Walk 1 Direction	To SW		X Walk 2 Direction	To SE
N/A	X Walk 1 Width (in)	N/A	N/A	X Walk 2 Width (in)	N/A
	X Walk 1 Slope (%)	2.8		X Walk 2 Slope (%)	0.2
	X Walk 1 X Slope (%)	3.4		X Walk 2 X Slope (%)	4.9

N/A	Ramp inside XWalk1?	N/A	N/A	Ramp inside XWalk2?	N/A
	Road Slope (%)	3.0	N/A	Clear Space?	N/A
	Road X Slope (%)	2.5	N/A	Clear Space to XWalk (in)	N/A
N/A	Any Obstructions?	N/A	N/A	Storm Grate/Utility Hazard?	N/A
	Obstruction Type			Storm Grate/Utility Type	
		N/A			N/A
			Yes	Surface Condition? (G/P)	Good

Possible Solutions:

Remove & Replace Curb Ramp With Two New Directional Ramps or Equivalent.

R304.5.1, R304.5.3

Total Cost: \$ 3200.00
