# Access Compliance Report

## Public Rights-of-Way

### (Curb Ramps)

| Intersection ID: 49253 | | Main Street: LEGATO_LN | | Cross Street: OAK_DR | | Location: SE | | | |

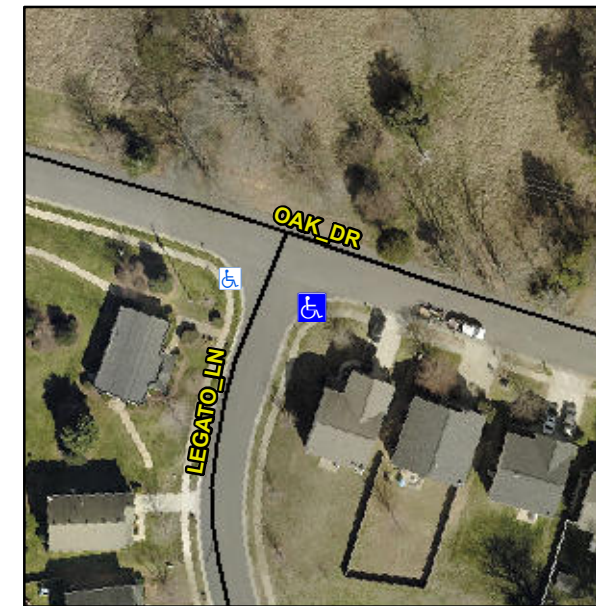
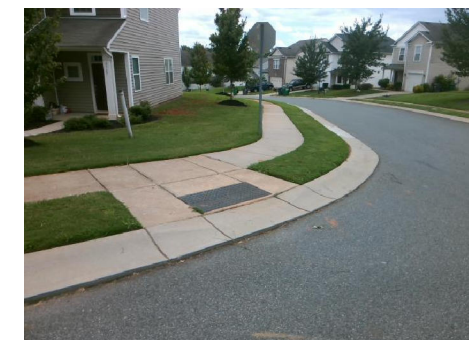
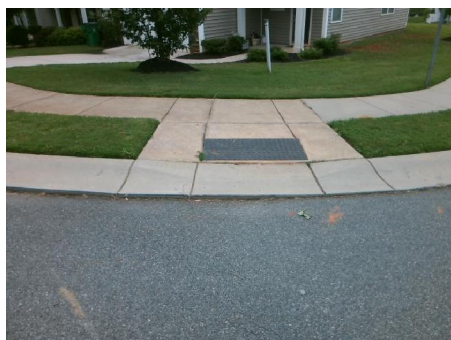
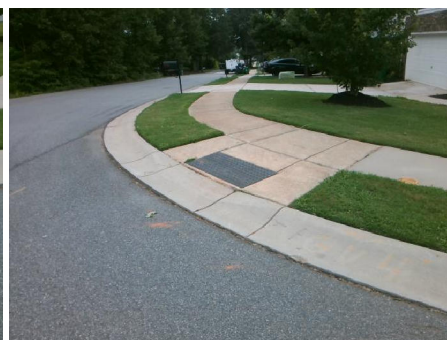
| ADA ID: 19BF54CB770E | | Ramp Type: Perp | | Initial Pass/Fail: Fail | | Overall Compliance: No | | Severity Score: 10 | |

**Not Found, R304.5.1, R304.5.3**

| Compliance | Description | Data | Compliance | Description | Data |
|---|---|---|---|---|---|
| N/A | Ramp Length (in) | 46.5 | Yes | Ramp Slope (%) | 6.4 |
| No | Ramp Width (in) | 44.5 | No | Ramp XSlope (%) | 3.2 |

**Remove & Replace Entire Ramp.**
