Access Compliance Report

Public Rights-of-Way

(Curb Ramps)

Intersection ID: 7826	Main Street: BROOKSHIRE_BV	Cross Street: DAKOTA_ST	Location: SE
ADA ID: 19CB1EF56B7C	Ramp Type: Para	Initial Pass/Fail: Fail	Overall Compliance: No
Codes/Mitigation Info/Possible Solution		Field Measurements/Component Compliance	
Severity Score: 13.75

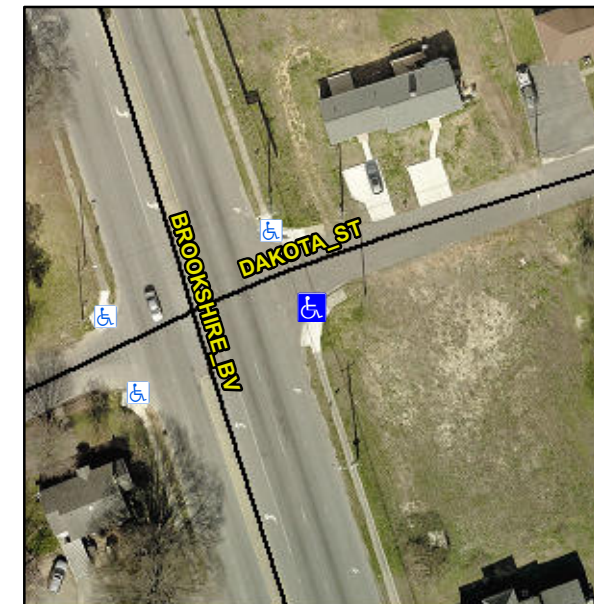
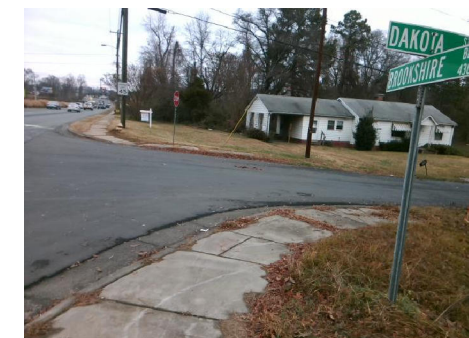
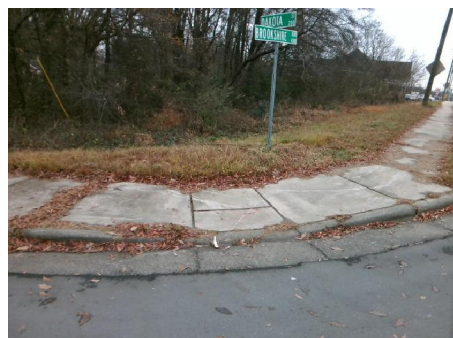
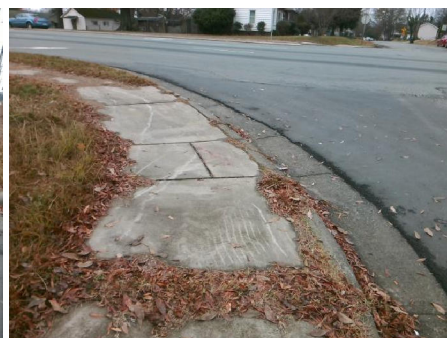
LT RP < 5%

R304.5.3, R304.3.2

Compliance	Description	Data	Compliance	Description	Data
N/A	Ramp Length LT (in)	54.0	N/A	Ramp Length RT (in)	62.0
Yes	Ramp Width LT (in)	67.0	Yes	Ramp Width RT (in)	67.0
Yes	Ramp Slope LT (%)	1.6	No	Ramp Slope RT (%)	11.3
No	Ramp XSlope LT (%)	3.8	Yes	Ramp XSlope RT (%)	1.9
N/A	Landing Length (in)	N/A	N/A	DWS Provided?	N/A
N/A	Landing Width (in)	N/A	N/A	DWS Contrast?	N/A
N/A	Landing Slope (%)	N/A	N/A	DWS Length (in)	N/A
N/A	Landing X Slope (%)	N/A	N/A	DWS Full Width?	N/A
N/A	Landing Curb? (Y/N)	N/A	N/A	DWS Offset (in)	N/A
N/A	Shared Landing?	N/A			
N/A	Gutter Ponding?	N/A	N/A	Gutter Slope (%)	N/A
N/A	Gutter Lip Ht (in)	N/A	N/A	Gutter X Slope (%)	N/A
N/A	Painted X Walk1?	No	N/A	Painted X Walk2?	N/A
	X Walk 1 Direction	To NW		X Walk 2 Direction	N/A
N/A	X Walk 1 Width (in)	N/A	N/A	X Walk 2 Width (in)	N/A
	X Walk 1 Slope (%)	4.5		X Walk 2 Slope (%)	N/A
	X Walk 1 X Slope (%)	1.6		X Walk 2 X Slope (%)	N/A
N/A	Ramp inside XWalk1?	N/A	N/A	Ramp inside XWalk2?	N/A

Road Slope (%)	N/A	N/A	Clear Space?	N/A
	Road X Slope (%)	N/A	N/A	Clear Space to XWalk (in)	N/A
N/A	Any Obstructions?	N/A	N/A	Storm Grate/Utility Hazard?	N/A
	Obstruction Type			Storm Grate/Utility Type	
		N/A			N/A
			Yes	Surface Condition? (G/P)	Good
			N/A	Curb Slope (%)	23.5

Possible Solutions:

Remove & Replace Entire Ramp.

Total Cost: \$ 1600.00
