## Access Compliance Report Public Rights-of-Way (Curb Ramps)

Intersection ID: 44470 Main Street: COREY\_COMMON\_AV Cross Street: NEWFIELD\_ST Location: N

ADA ID: 19CB29622CE0 Ramp Type: BlendTrans1 Initial Pass/Fail: Fail Overall Compliance: No Severity Score: 10

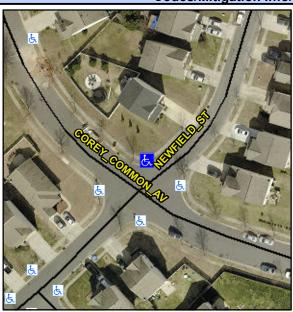
Not Found, R304.5.1, R304.5.3

Fleid Measur	ements/C	<u>ompo</u>	nent Compliance	
Compliance Description		Data	Comp	liance Description	Data
N/A	Ramp Length (in)	48.0	Yes	BlendTrans Slope (%)	3.4
No	Ramp Width (in)	45.5	No	BlendTrans XSlope (%)	2.4
N/A	Flare Type LT	N/A	N/A	Flare Type RT	N/A
N/A	Flare Slope LT (%)	N/A	N/A	Flare Slope RT (%)	N/A
N/A	Flare Traversable LT?	N/A	N/A	Flare Traversable RT?	N/A
N/A	Landing Length (in)	N/A	N/A	DWS Provided?	N/A
N/A	Landing Width (in)	N/A	N/A	DWS Contrast?	N/A
N/A	Landing Slope (%)	N/A	N/A	DWS Length (in)	N/A
N/A	Landing X Slope (%)	N/A	N/A	DWS Full Width?	N/A
N/A	Landing Curb? (Y/N)	N/A	N/A	DWS Offset (in)	N/A
N/A	Shared Landing?	N/A			
N/A	Gutter Ponding?	N/A	N/A	Gutter Slope (%)	N/A
N/A	Gutter Lip Ht (in)	N/A	N/A	Gutter X Slope (%)	N/A
N/A	Painted X Walk1?	No	N/A	Painted X Walk2?	No
	X Walk 1 Direction	To SW		X Walk 2 Direction	To SE
	X Walk 1 Width (in)	N/A		X Walk 2 Width (in)	N/A
	X Walk 1 Slope (%)	0.9		X Walk 2 Slope (%)	1.5

X Walk 1 X Slope (%)	1.3		X Walk 2 X Slope (%)	2.0
N/A	Ramp inside XWalk1?	N/A	N/A	Ramp inside XWalk2?	N/A
	Road Slope (%)	4.0		Clear Space?	N/A
	Road X Slope (%)	0.4	N/A	Clear Space to XWalk (in)	N/A
N/A	Any Obstructions?	N/A	N/A	Storm Grate/Utility Hazard?	N/A

Remove & Replace Curb Ramp With Two New Directional Ramps or Equivalent.
