# Access Compliance Report

## Public Rights-of-Way

| Intersection ID: 12248 | Main Street: E_8TH_ST | Cross Street: N_BREVARD_ST | Location: | N |
| ADA ID: 19CB3152129E | Ramp Type: Perp | Initial Pass/Fail: Pass | Overall Compliance: No | Severity Score: 10 |

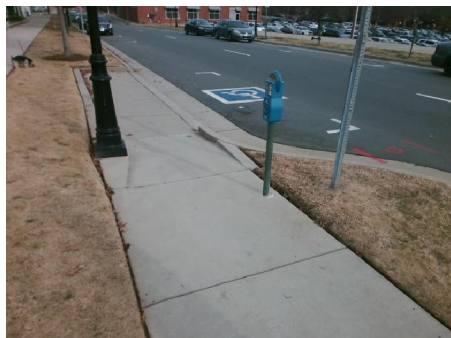
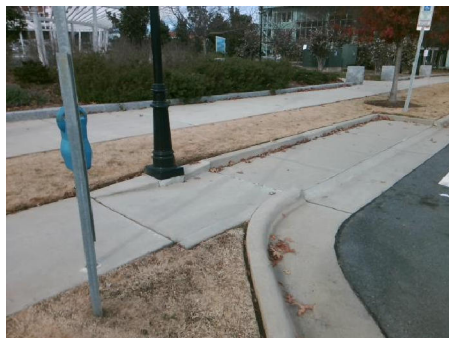
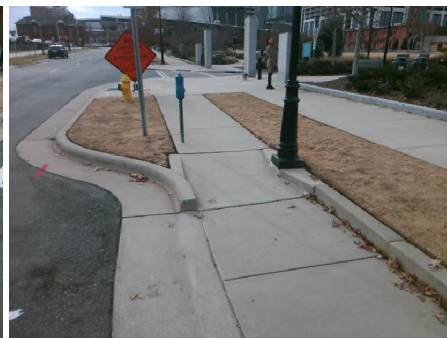
| Compliance | Description | Data | Compliance | Description | Data |
|---|---|---|---|---|---|
| Yes | Landing Length (in) | 64.0 | No | DWS Provided? | No |
| No | Landing Slope (%) | 2.7 | N/A | DWS Length (in) | N/A |
| Yes | Gutter Ponding? | No | No | Gutter Slope (%) | N/A |
| No | Gutter Lip Ht (in) | N/A | No | Gutter X Slope (%) | N/A |

**Remove & Replace Entire Ramp.  
Remove & Replace Gutter.**

**R304.2.2-Perp, R304.3.2-Para, R305,  
R302.7.2, R304.5.4, R304.5.3**

Total Cost: \$ 2600.00
