Access Compliance Report

Public Rights-of-Way

(Curb Ramps)

Intersection ID: 48713	Main Street: ROLLING_CREEK_CT	Cross Street: KILCULLEN_DR	Location: S
ADA ID: 19D1DC407E93	Ramp Type: Perp	Initial Pass/Fail: Fail	Overall Compliance: No
Severity Score: 13.75			
Codes/Mitigation Info/Possible Solution		Field Measurements/Component Compliance

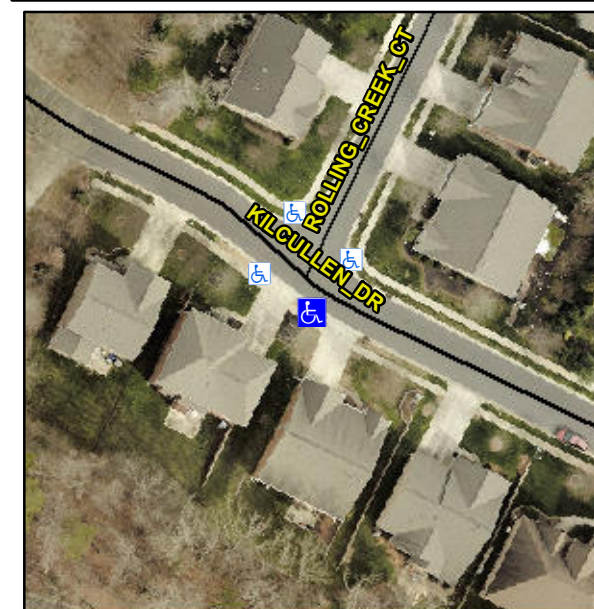
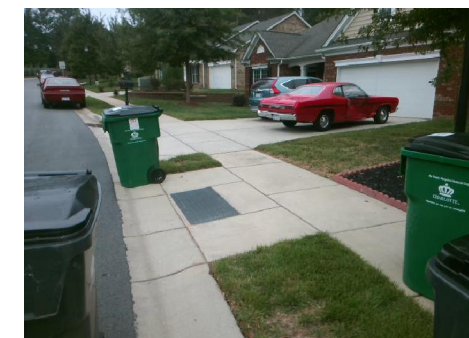
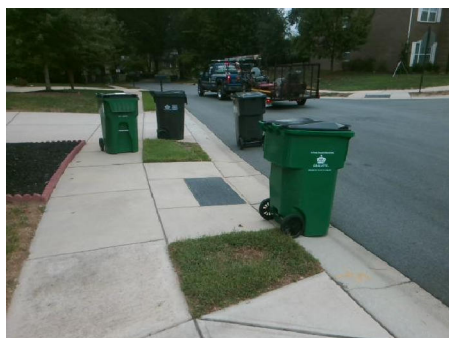
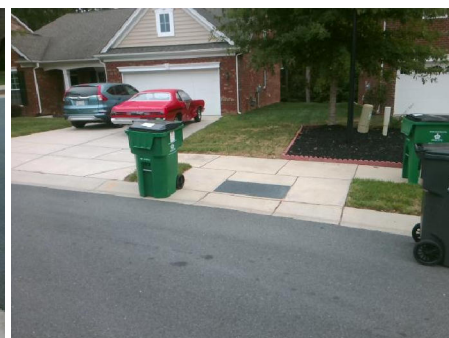
Compliance	Description	Data	Compliance	Description	Data
N/A	Ramp Length (in)	47.0	No	Ramp Slope (%)	8.8
Yes	Ramp Width (in)	48.0	No	Ramp XSlope (%)	4.0
N/A	Flare Type LT	N/A	N/A	Flare Type RT	N/A
N/A	Flare Slope LT (%)	N/A	N/A	Flare Slope RT (%)	N/A
N/A	Flare Traversable LT?	N/A	N/A	Flare Traversable RT?	N/A
N/A	Landing Length (in)	N/A	N/A	DWS Provided?	N/A
N/A	Landing Width (in)	N/A	N/A	DWS Contrast?	N/A
N/A	Landing Slope (%)	N/A	N/A	DWS Length (in)	N/A
N/A	Landing X Slope (%)	N/A	N/A	DWS Full Width?	N/A
N/A	Landing Curb? (Y/N)	N/A	N/A	DWS Offset (in)	N/A
N/A	Shared Landing?	N/A			
N/A	Gutter Ponding?	N/A	N/A	Gutter Slope (%)	N/A
N/A	Gutter Lip Ht (in)	N/A	N/A	Gutter X Slope (%)	N/A
N/A	Painted X Walk1?	No	N/A	Painted X Walk2?	N/A
	X Walk 1 Direction	To NE		X Walk 2 Direction	N/A
N/A	X Walk 1 Width (in)	N/A	N/A	X Walk 2 Width (in)	N/A
	X Walk 1 Slope (%)	2.2		X Walk 2 Slope (%)	N/A
	X Walk 1 X Slope (%)	3.3		X Walk 2 X Slope (%)	N/A

N/A	Ramp inside XWalk1?	N/A	N/A	Ramp inside XWalk2?	N/A
	Road Slope (%)	N/A	N/A	Clear Space?	N/A
	Road X Slope (%)	N/A	N/A	Clear Space to XWalk (in)	N/A
N/A	Any Obstructions?	N/A	N/A	Storm Grate/Utility Hazard?	N/A
	Obstruction Type			Storm Grate/Utility Type	
		N/A			N/A
			Yes	Surface Condition? (G/P)	Good

Remove & Replace Entire Ramp.

R304.2.2, R304.5.3
