Access Compliance Report

Public Rights-of-Way

(Curb Ramps)

Intersection ID: 43499	Main Street: MCALLISTER_PARK_DR	Cross Street: PRESCOTT_HILL_AV	Location: SE
ADA ID: 19D2832B8EAE	Ramp Type: PerpDiag	Initial Pass/Fail: Fail	Overall Compliance: No
Severity Score: 36.25			
Codes/Mitigation Info/Possible Solution		Field Measurements/Component Compliance

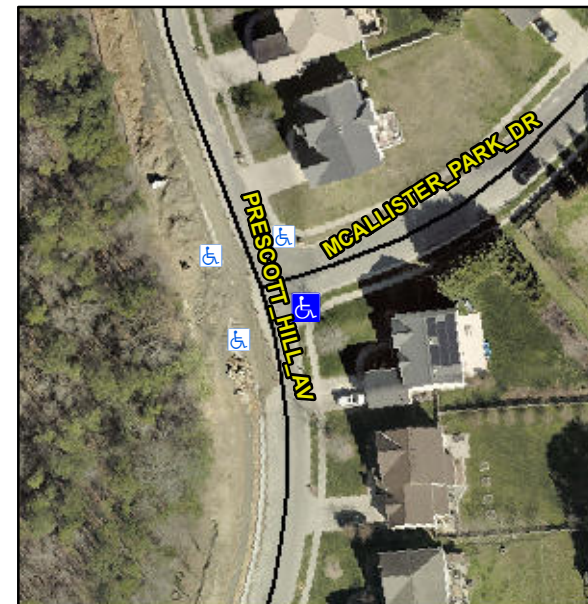
Not Found, R304.5.1, R304.5.3

Compliance	Description	Data	Compliance	Description	Data
N/A	Ramp Length (in)	96.0	Yes	Ramp Slope (%)	5.2
No	Ramp Width (in)	27.0	No	Ramp XSlope (%)	3.6
N/A	Flare Type LT	N/A	N/A	Flare Type RT	N/A
N/A	Flare Slope LT (%)	N/A	N/A	Flare Slope RT (%)	N/A
N/A	Flare Traversable LT?	N/A	N/A	Flare Traversable RT?	N/A
N/A	Landing Length (in)	N/A	N/A	DWS Provided?	N/A
N/A	Landing Width (in)	N/A	N/A	DWS Contrast?	N/A
N/A	Landing Slope (%)	N/A	N/A	DWS Length (in)	N/A
N/A	Landing X Slope (%)	N/A	N/A	DWS Full Width?	N/A
N/A	Landing Curb? (Y/N)	N/A	N/A	DWS Offset (in)	N/A
N/A	Shared Landing?	N/A			
N/A	Gutter Ponding?	N/A	N/A	Gutter Slope (%)	N/A
N/A	Gutter Lip Ht (in)	N/A	N/A	Gutter X Slope (%)	N/A
N/A	Painted X Walk1?	No	N/A	Painted X Walk2?	No
	X Walk 1 Direction	To N		X Walk 2 Direction	To W
N/A	X Walk 1 Width (in)	N/A	N/A	X Walk 2 Width (in)	N/A
	X Walk 1 Slope (%)	1.8		X Walk 2 Slope (%)	5.6
	X Walk 1 X Slope (%)	3.7		X Walk 2 X Slope (%)	1.8

N/A	Ramp inside XWalk1?	N/A	N/A	Ramp inside XWalk2?	N/A
	Road Slope (%)	1.7	N/A	Clear Space?	N/A
	Road X Slope (%)	3.6	N/A	Clear Space to XWalk (in)	N/A
N/A	Any Obstructions?	N/A	N/A	Storm Grate/Utility Hazard?	N/A
	Obstruction Type			Storm Grate/Utility Type	
		N/A			N/A
			Yes	Surface Condition? (G/P)	Good

Possible Solutions:

Remove & Replace Curb Ramp With Two New Directional Ramps or Equivalent.
