Access Compliance Report

Public Rights-of-Way

(Curb Ramps)

Intersection ID: N/A	Main Street: INDEPENDENCE BV	Cross Street: N/A	Location: N
ADA ID: 19D2DBE98404	Ramp Type: Perp	Initial Pass/Fail: Fail	Overall Compliance: No
Codes/Mitigation Info/Possible Solution		Field Measurements/Component Compliance

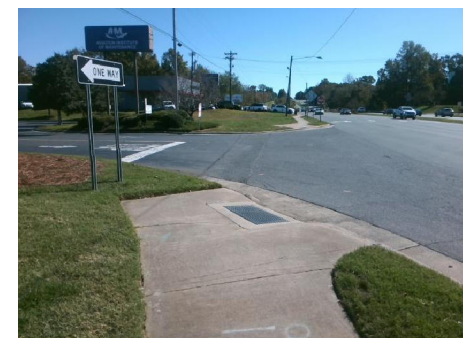
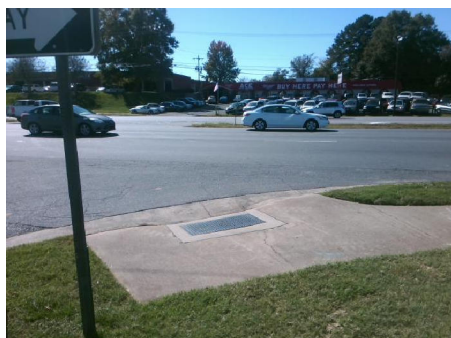
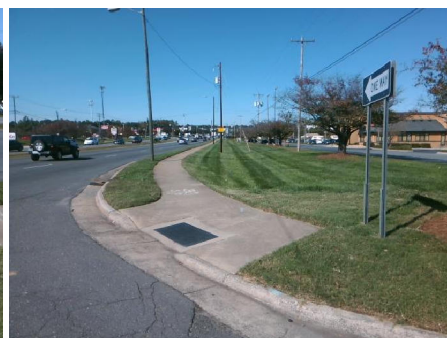
Not Found, R304.2.2, R304.5.3

Compliance	Description	Data	Compliance	Description	Data
N/A	Ramp Length (in)	101.0	No	Ramp Slope (%)	11.6
Yes	Ramp Width (in)	48.0	No	Ramp XSlope (%)	2.8
N/A	Flare Type LT	N/A	N/A	Flare Type RT	N/A
N/A	Flare Slope LT (%)	N/A	N/A	Flare Slope RT (%)	N/A
N/A	Flare Traversable LT?	N/A	N/A	Flare Traversable RT?	N/A
N/A	Landing Length (in)	N/A	N/A	DWS Provided?	N/A
N/A	Landing Width (in)	N/A	N/A	DWS Contrast?	N/A
N/A	Landing Slope (%)	N/A	N/A	DWS Length (in)	N/A
N/A	Landing X Slope (%)	N/A	N/A	DWS Full Width?	N/A
N/A	Landing Curb? (Y/N)	N/A	N/A	DWS Offset (in)	N/A
N/A	Shared Landing?	N/A			
N/A	Gutter Ponding?	N/A	N/A	Gutter Slope (%)	N/A
N/A	Gutter Lip Ht (in)	N/A	N/A	Gutter X Slope (%)	N/A
N/A	Painted X Walk1?	No	N/A	Painted X Walk2?	N/A
	X Walk 1 Direction	To SE		X Walk 2 Direction	N/A
N/A	X Walk 1 Width (in)	N/A	N/A	X Walk 2 Width (in)	N/A
	X Walk 1 Slope (%)	0.2		X Walk 2 Slope (%)	N/A
	X Walk 1 X Slope (%)	2.2		X Walk 2 X Slope (%)	N/A

N/A	Ramp inside XWalk1?	N/A	N/A	Ramp inside XWalk2?	N/A
	Road Slope (%)	N/A	N/A	Clear Space?	N/A
	Road X Slope (%)	N/A	N/A	Clear Space to XWalk (in)	N/A
N/A	Any Obstructions?	N/A	N/A	Storm Grate/Utility Hazard?	N/A
	Obstruction Type			Storm Grate/Utility Type	
		N/A			N/A
			Yes	Surface Condition? (G/P)	Good

Remove & Replace Entire Ramp.
