Access Compliance Report

Public Rights-of-Way

(Curb Ramps)

Intersection ID: 13779	Main Street: CENTRAL_AV	Cross Street: MEDFORD_DR	Location: NW
ADA ID: 19D9FFDC07FA	Ramp Type: Perp	Initial Pass/Fail: Fail	Overall Compliance: No
Severity Score: 30			
Codes/Mitigation Info/Possible Solution		Field Measurements/Component Compliance

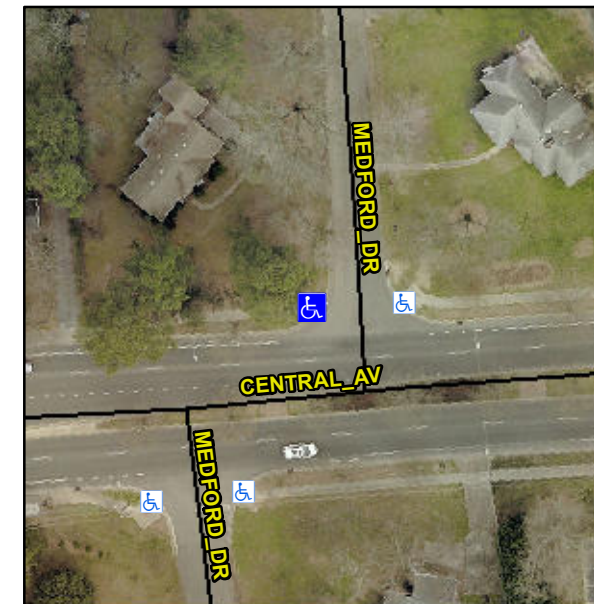
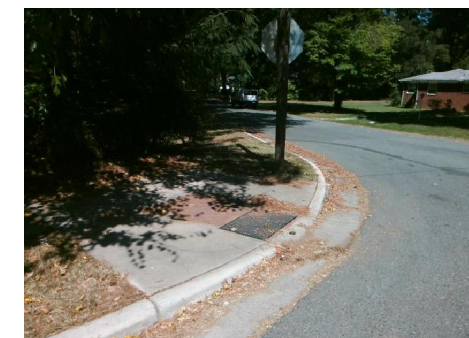
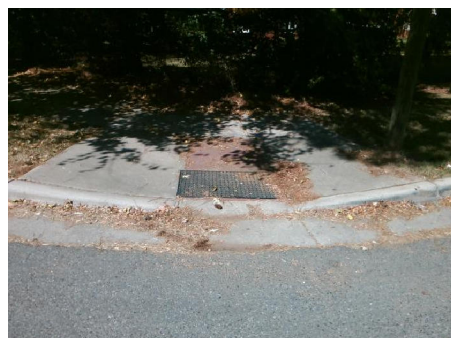
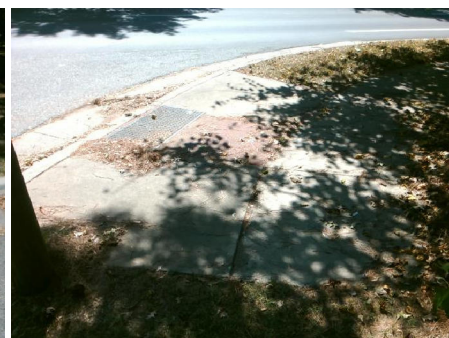
Not Found, R304.5.1, R304.5.3

Compliance	Description	Data	Compliance	Description	Data
N/A	Ramp Length (in)	71.0	Yes	Ramp Slope (%)	5.3
No	Ramp Width (in)	35.0	No	Ramp XSlope (%)	5.7
N/A	Flare Type LT	N/A	N/A	Flare Type RT	N/A
N/A	Flare Slope LT (%)	N/A	N/A	Flare Slope RT (%)	N/A
N/A	Flare Traversable LT?	N/A	N/A	Flare Traversable RT?	N/A
N/A	Landing Length (in)	N/A	N/A	DWS Provided?	N/A
N/A	Landing Width (in)	N/A	N/A	DWS Contrast?	N/A
N/A	Landing Slope (%)	N/A	N/A	DWS Length (in)	N/A
N/A	Landing X Slope (%)	N/A	N/A	DWS Full Width?	N/A
N/A	Landing Curb? (Y/N)	N/A	N/A	DWS Offset (in)	N/A
N/A	Shared Landing?	N/A			
N/A	Gutter Ponding?	Yes	N/A	Gutter Slope (%)	N/A
N/A	Gutter Lip Ht (in)	0.5	N/A	Gutter X Slope (%)	N/A
N/A	Painted X Walk1?	No	N/A	Painted X Walk2?	N/A
	X Walk 1 Direction	To E		X Walk 2 Direction	N/A
N/A	X Walk 1 Width (in)	N/A	N/A	X Walk 2 Width (in)	N/A
	X Walk 1 Slope (%)	1.3		X Walk 2 Slope (%)	N/A
	X Walk 1 X Slope (%)	4.6		X Walk 2 X Slope (%)	N/A

N/A	Ramp inside XWalk1?	N/A	N/A	Ramp inside XWalk2?	N/A
	Road Slope (%)	N/A	N/A	Clear Space?	N/A
	Road X Slope (%)	N/A	N/A	Clear Space to XWalk (in)	N/A
N/A	Any Obstructions?	N/A	N/A	Storm Grate/Utility Hazard?	N/A
	Obstruction Type			Storm Grate/Utility Type	
		N/A			N/A
		Yes		Surface Condition? (G/P)	Good

Possible Solutions:

Remove & Replace Entire Ramp.
