Access Compliance Report

Public Rights-of-Way

(Curb Ramps)

Intersection ID: 47035	Main Street: W_ARROWWOOD_RD	Cross Street: STONEGROVE_LN	Location: SE
ADA ID: 19E9E93675D6	Ramp Type: Perp	Initial Pass/Fail: Fail	Overall Compliance: No
		Severity Score: 12.5

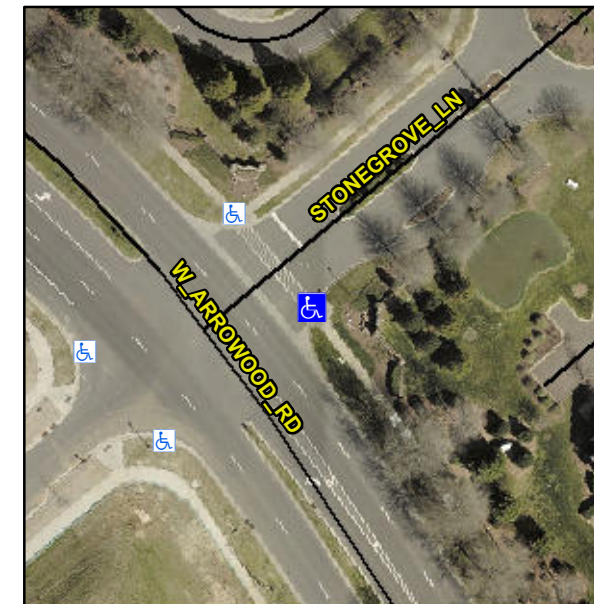
Not Found, R304.5.3

Compliance	Description	Data	Compliance	Description	Data
N/A	Ramp Length (in)	53.5	Yes	Ramp Slope (%)	5.1
Yes	Ramp Width (in)	49.0	No	Ramp XSlope (%)	6.5
N/A	Flare Type LT	N/A	N/A	Flare Type RT	N/A
N/A	Flare Slope LT (%)	N/A	N/A	Flare Slope RT (%)	N/A
N/A	Flare Traversable LT?	N/A	N/A	Flare Traversable RT?	N/A
N/A	Landing Length (in)	N/A	N/A	DWS Provided?	N/A
N/A	Landing Width (in)	N/A	N/A	DWS Contrast?	N/A
N/A	Landing Slope (%)	N/A	N/A	DWS Length (in)	N/A
N/A	Landing X Slope (%)	N/A	N/A	DWS Full Width?	N/A
N/A	Landing Curb? (Y/N)	N/A	N/A	DWS Offset (in)	N/A
N/A	Shared Landing?	N/A			
N/A	Gutter Ponding?	N/A	N/A	Gutter Slope (%)	N/A
N/A	Gutter Lip Ht (in)	N/A	N/A	Gutter X Slope (%)	N/A
N/A	Painted X Walk1?	Yes	N/A	Painted X Walk2?	N/A
	X Walk 1 Direction	To NW		X Walk 2 Direction	N/A
N/A	X Walk 1 Width (in)	68.0	N/A	X Walk 2 Width (in)	N/A
	X Walk 1 Slope (%)	0.4		X Walk 2 Slope (%)	N/A
	X Walk 1 X Slope (%)	6.3		X Walk 2 X Slope (%)	N/A

N/A	Ramp inside XWalk1?	Yes	N/A	Ramp inside XWalk2?	N/A
	Road Slope (%)	N/A	N/A	Clear Space?	N/A
	Road X Slope (%)	N/A	N/A	Clear Space to XWalk (in)	N/A
N/A	Any Obstructions?	N/A	N/A	Storm Grate/Utility Hazard?	N/A
	Obstruction Type			Storm Grate/Utility Type	
		N/A			N/A
			Yes	Surface Condition? (G/P)	Good

Remove & Replace Entire Ramp.

Total Cost: \$ 1850.00
