# Access Compliance Report

## Public Rights-of-Way

### (Curb Ramps)

Intersection ID: 28117	Main Street: AUTUMN_APPLAUSE_DR	Cross Street: BLAKENEY_DR	Location: NE
ADA ID: 19ECF103CB64	Ramp Type: BlendTrans2	Initial Pass/Fail: Fail	Overall Compliance: No
		Severity Score: 8.75

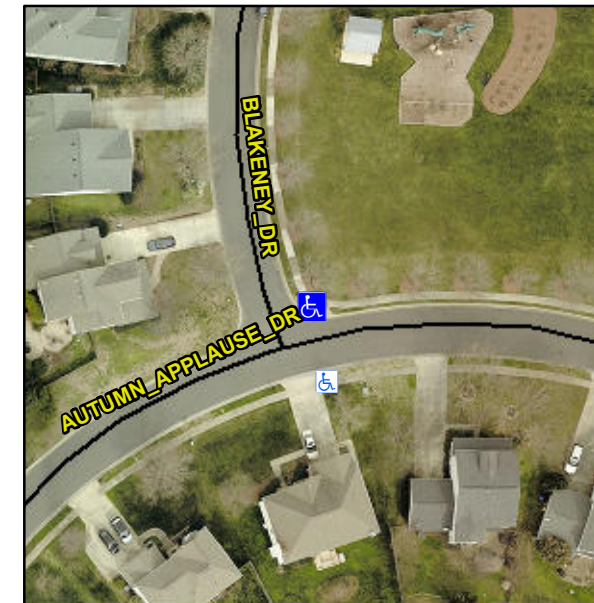
**Not Found, R304.5.1**

Compliance	Description	Data	Compliance	Description	Data
N/A	Ramp Length (in)	100.0	Yes	BlendTrans Slope (%)	2.1
No	Ramp Width (in)	36.0	Yes	BlendTrans XSlope (%)	0.4
N/A	Flare Type LT	N/A	N/A	Flare Type RT	N/A
N/A	Flare Slope LT (%)	N/A	N/A	Flare Slope RT (%)	N/A
N/A	Flare Traversable LT?	N/A	N/A	Flare Traversable RT?	N/A
N/A	Landing Length (in)	N/A	N/A	DWS Provided?	N/A
N/A	Landing Width (in)	N/A	N/A	DWS Contrast?	N/A
N/A	Landing Slope (%)	N/A	N/A	DWS Length (in)	N/A
N/A	Landing X Slope (%)	N/A	N/A	DWS Full Width?	N/A
N/A	Landing Curb? (Y/N)	N/A	N/A	DWS Offset (in)	N/A
N/A	Shared Landing?	N/A			
N/A	Gutter Ponding?	N/A	N/A	Gutter Slope (%)	N/A
N/A	Gutter Lip Ht (in)	N/A	N/A	Gutter X Slope (%)	N/A
N/A	Painted X Walk1?	No	N/A	Painted X Walk2?	No
	X Walk 1 Direction	To W		X Walk 2 Direction	To S
	X Walk 1 Width (in)	N/A		X Walk 2 Width (in)	N/A
	X Walk 1 Slope (%)	2.3		X Walk 2 Slope (%)	2.2
	X Walk 1 X Slope (%)	0.0		X Walk 2 X Slope (%)	1.5

N/A	Ramp inside XWalk1?	N/A	N/A	Ramp inside XWalk2?	N/A
	Road Slope (%)	1.1		Clear Space?	N/A
	Road X Slope (%)	3.2	N/A	Clear Space to XWalk (in)	N/A
N/A	Any Obstructions?	N/A	N/A	Storm Grate/Utility Hazard?	N/A
	Obstruction Type			Storm Grate/Utility Type	
		N/A			N/A
			Yes	Surface Condition? (G/P)	Good
			No	Curb Slope (%)	5.2

**Remove & Replace Curb Ramp With Two New Directional Ramps or Equivalent.**

Total Cost: \$ 3200.00
