# Access Compliance Report

## Public Rights-of-Way

### (Curb Ramps)

Intersection ID: 54269	Main Street: JOHNSTON_OEHLER_RD	Cross Street: OEHLER_BRIDGE_DR	Location:	N
ADA ID: 19F2859D4C65	Ramp Type: Perp	Initial Pass/Fail: Pass	Overall Compliance: Yes	Severity Score: 0
Codes/Mitigation Info/Possible Solution		Field Measurements/Component Compliance

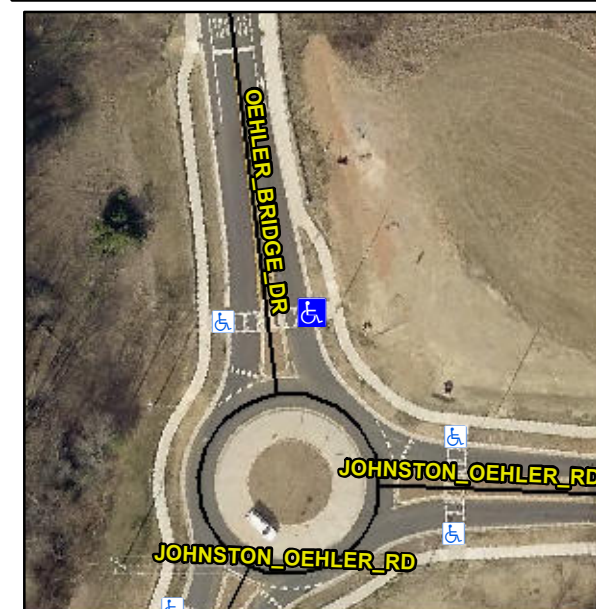
Compliance	Description	Data	Compliance	Description	Data
N/A	Ramp Length (in)	96.5	Yes	Ramp Slope (%)	7.7
Yes	Ramp Width (in)	69.0	Yes	Ramp XSlope (%)	0.8
Yes	Flare Type LT	Curbed_NoWalkSurface	Yes	Flare Type RT	N/A
Yes	Flare Slope LT (%)	N/A	N/A	Flare Slope RT (%)	N/A
N/A	Flare Traversable LT?	No	N/A	Flare Traversable RT?	No
Yes	Landing Length (in)	71.0	Yes	DWS Provided?	Yes
Yes	Landing Width (in)	84.0	Yes	DWS Contrast?	Yes
Yes	Landing Slope (%)	2.0	Yes	DWS Length (in)	24.0
Yes	Landing X Slope (%)	1.0	Yes	DWS Full Width?	Yes
N/A	Landing Curb? (Y/N)	No	Yes	DWS Offset (in)	0.0
N/A	Shared Landing?	No			
Yes	Gutter Ponding?	No	Yes	Gutter Slope (%)	3.6
Yes	Gutter Lip Ht (in)	0.0	Yes	Gutter X Slope (%)	1.7
N/A	Painted X Walk1?	Yes	N/A	Painted X Walk2?	N/A
	X Walk 1 Direction	To W		X Walk 2 Direction	N/A
N/A	X Walk 1 Width (in)	111.5	N/A	X Walk 2 Width (in)	N/A
	X Walk 1 Slope (%)	2.8		X Walk 2 Slope (%)	N/A
	X Walk 1 X Slope (%)	1.5		X Walk 2 X Slope (%)	N/A

Yes	Ramp inside XWalk1?	Yes	N/A	Ramp inside XWalk2?	N/A
	Road Slope (%)	N/A	N/A	Clear Space?	Yes
	Road X Slope (%)	N/A	N/A	Clear Space to XWalk (in)	N/A
Yes	Any Obstructions?	No	Yes	Storm Grate/Utility Hazard?	No
	Obstruction Type			Storm Grate/Utility Type	
		N/A			N/A
			Yes	Surface Condition? (G/P)	Good

Possible Solutions:

N/A
