# Access Compliance Report

## Public Rights-of-Way

### (Curb Ramps)

Intersection ID: 14846	Main Street: HENLEY_PL	Cross Street: S_KINGS_DR	Location: NE
ADA ID: 19FA4148CC0C	Ramp Type: Perp	Initial Pass/Fail: Fail	Overall Compliance: No
Severity Score: 13.75			
Codes/Mitigation Info/Possible Solution		Field Measurements/Component Compliance

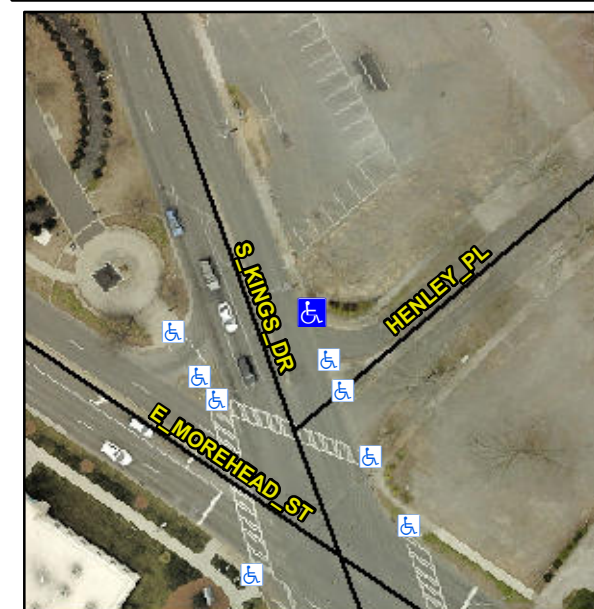
**Not Found, R304.2.2, R304.5.3**

Compliance	Description	Data	Compliance	Description	Data
N/A	Ramp Length (in)	61.5	No	Ramp Slope (%)	8.8
Yes	Ramp Width (in)	48.0	No	Ramp XSlope (%)	3.7
N/A	Flare Type LT	N/A	N/A	Flare Type RT	N/A
N/A	Flare Slope LT (%)	N/A	N/A	Flare Slope RT (%)	N/A
N/A	Flare Traversable LT?	N/A	N/A	Flare Traversable RT?	N/A
N/A	Landing Length (in)	N/A	N/A	DWS Provided?	N/A
N/A	Landing Width (in)	N/A	N/A	DWS Contrast?	N/A
N/A	Landing Slope (%)	N/A	N/A	DWS Length (in)	N/A
N/A	Landing X Slope (%)	N/A	N/A	DWS Full Width?	N/A
N/A	Landing Curb? (Y/N)	N/A	N/A	DWS Offset (in)	N/A
N/A	Shared Landing?	N/A			
N/A	Gutter Ponding?	N/A	N/A	Gutter Slope (%)	N/A
N/A	Gutter Lip Ht (in)	N/A	N/A	Gutter X Slope (%)	N/A
N/A	Painted X Walk1?	No	N/A	Painted X Walk2?	N/A
	X Walk 1 Direction	To S		X Walk 2 Direction	N/A
N/A	X Walk 1 Width (in)	N/A	N/A	X Walk 2 Width (in)	N/A
	X Walk 1 Slope (%)	3.3		X Walk 2 Slope (%)	N/A
	X Walk 1 X Slope (%)	0.5		X Walk 2 X Slope (%)	N/A

N/A	Ramp inside XWalk1?	N/A	N/A	Ramp inside XWalk2?	N/A
	Road Slope (%)	N/A	N/A	Clear Space?	N/A
	Road X Slope (%)	N/A	N/A	Clear Space to XWalk (in)	N/A
N/A	Any Obstructions?	N/A	N/A	Storm Grate/Utility Hazard?	N/A
	Obstruction Type			Storm Grate/Utility Type	
		N/A			N/A
			Yes	Surface Condition? (G/P)	Good

**Remove & Replace Entire Ramp.**

Total Cost: \$ 1850.00
