Access Compliance Report

Public Rights-of-Way

(Curb Ramps)

Intersection ID: N/A	Main Street: SOUTHGROVE_ST	Cross Street: ARDREY_KELL_RD	Location: SW
ADA ID: 1A02AEDD392F	Ramp Type: Directional1	Initial Pass/Fail: Pass	Overall Compliance: No
		Severity Score: 2.5

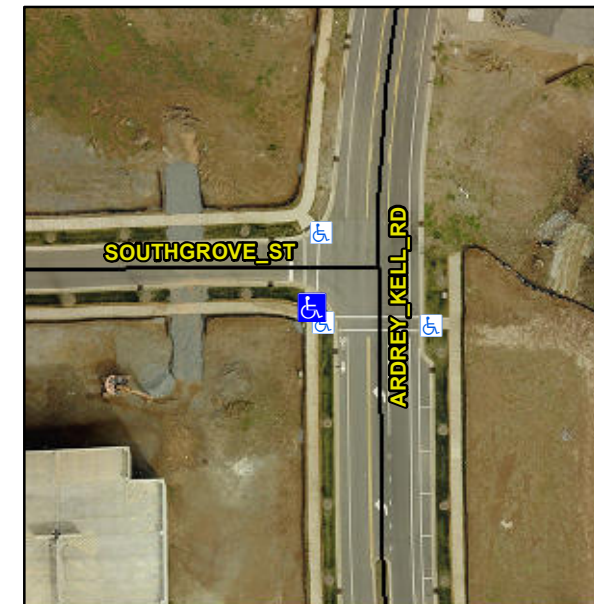
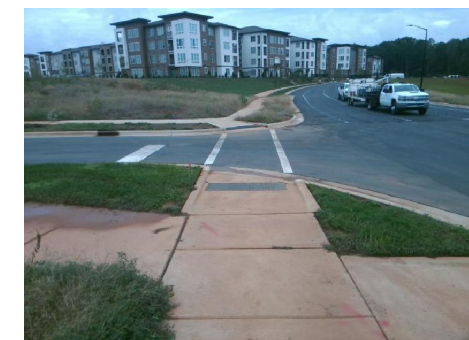
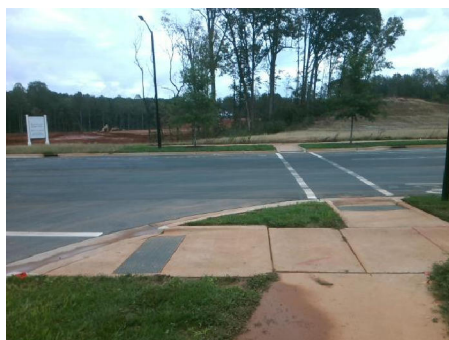
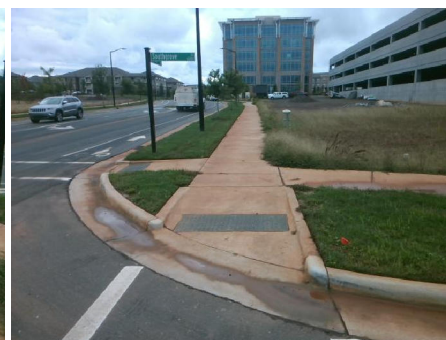
Not Found, R304.2.1, R304.5.2, R305.1.4

Compliance	Description	Data	Compliance	Description	Data
N/A	Ramp Length (in)	74.0	No	Grade Break?	No
Yes	Ramp Width (in)	69.5	N/A	Grade Break Slope (%)	5.6
Yes	Ramp Slope (%)	7.4	N/A	Grade Break XSlope (%)	0.4
Yes	Ramp XSlope (%)	1.8			
Yes	Flare Type LT	N/A	Yes	Flare Type RT	N/A
N/A	Flare Slope LT (%)	N/A	N/A	Flare Slope RT (%)	N/A
N/A	Flare Traversable LT?	No	N/A	Flare Traversable RT?	No
No	Landing Length (in)	44.0	Yes	DWS Provided?	Yes
Yes	Landing Width (in)	70.0	Yes	DWS Contrast?	Yes
Yes	Landing Slope (%)	1.8	Yes	DWS Length (in)	24.0
Yes	Landing X Slope (%)	1.3	No	DWS Full Width?	No
N/A	Landing Curb? (Y/N)	N/A	Yes	DWS Offset LT (in)	0.0
N/A	Shared Landing?	No	Yes	DWS Offset RT (in)	38.0
Yes	Gutter Ponding?	No	Yes	Gutter Slope (%)	4.1
Yes	Gutter Lip Ht (in)	0.0	Yes	Gutter X Slope (%)	0.1
N/A	Painted X Walk1?	Yes		Road Slope (%)	2.8
	X Walk 1 Direction	To NW		Road X Slope (%)	0.8
	X Walk 1 Width (in)	70.0		Clear Space?	Yes

X Walk 1 Slope (%)	2.8	N/A	Clear Space to XWalk (in)	N/A
	X Walk 1 X Slope (%)	0.8	Yes	Storm Grate/Utility Hazard?	No
Yes	Ramp inside XWalk1?	Yes		Storm Grate/Utility Type	
Yes	Any Obstructions?	No			N/A
	Obstruction Type		Yes	Surface Condition? (G/P)	Good
			N/A	Curb Slope (%)	10.6

Remove & Replace Entire Ramp.
